APPENDIX D
ARCHAEOLOGICAL MONITORING
AND
MISCELLANEOUS ARCHAEOLOGICAL DATA

During the Phase 1 archaeological assessment of the Dunhams Block the basement and ground floor levels of all the premises within the block were examined. Various features of archaeological and architectural interest were observed, most of which have been discussed either in the first volume of this report or in the historic architectural report prepared by Acroterion (1988).

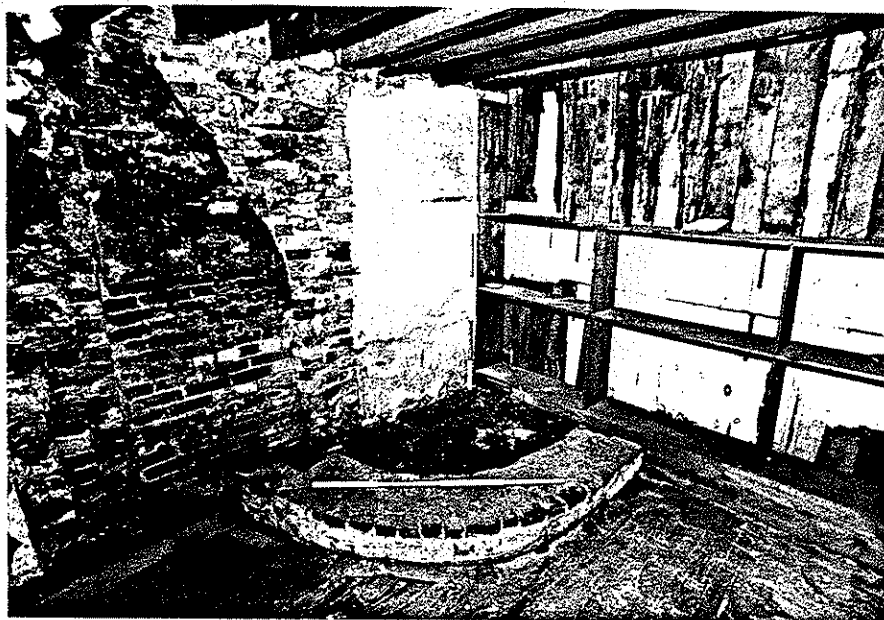
Plate D.1. 8 East State Street: view looking northwest showing fireplace and chimney base in west wall and possible furnace base in floor; scale in feet (Photographer: Richard Hunter, July 1987).

Two properties that deserve further mention are 8 and 10 East State Street. The basements of both of these premises contained features of archaeological and architectural interest that have so far received minimal description. In the west foundation wall of 8 East State Street were the remains of a fireplace and chimney base and furnace footing (Plate D.1). While the latter feature probably dated from the late 19th century, the fireplace and chimney base appear to have been original elements in the building, dating from around 1833 when 2-6 North Warren and 2-10 East State Streets were built as a single structural development (see above, Appendix A.iii).

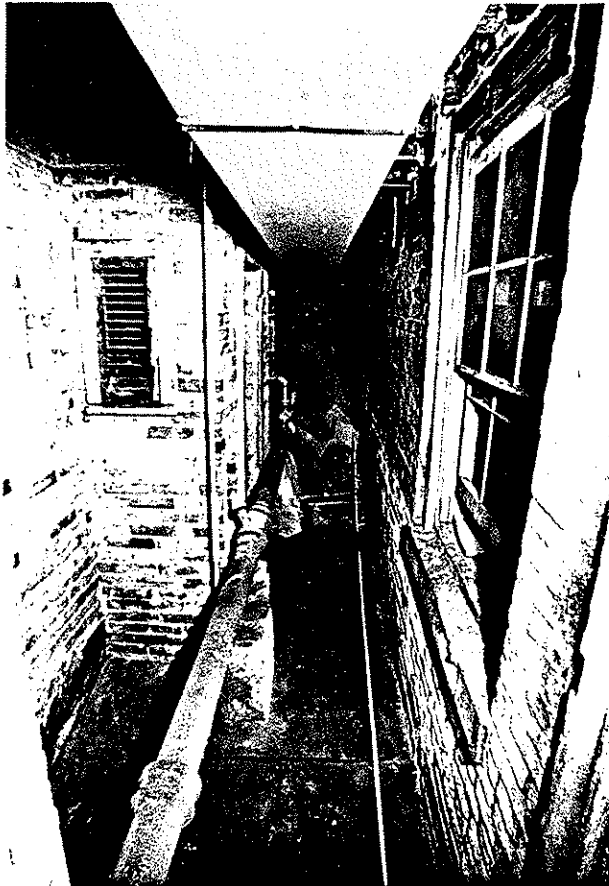
Plate D.2. 10 East State Street:
view looking north into rear yard
now enclosed within building. Privy
located through doorway at left-
center of photograph; scale in feet,
(Photographer: Richard Hunter, July
1987).

In the basement of 10 East State Street was a section of what appeared to have been a "sunken" rear yard along the western edge of the property. A narrow alley with an exterior wall was evident (Plate D.2) along the north side of which was a well-preserved three-seater privy (Plates D.3 and D.4). The yard and perhaps also the privy are believed to have been original features of the same circa 1833 building episode noted above for 8 East State Street (see above, Appendix A.iii; Acroterion 1988: 10 East State Street).

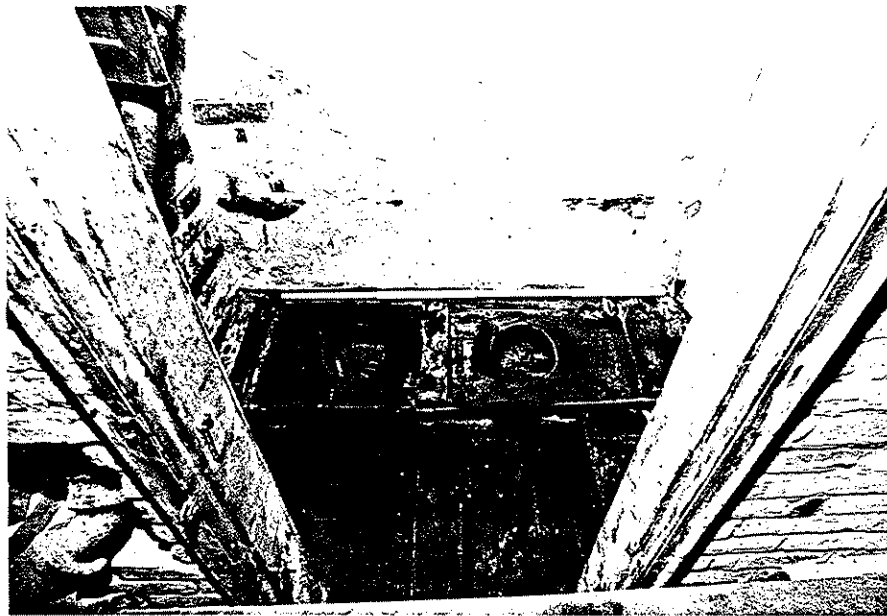
Plate D.3. 10 East State Street: oblique view of three-seater privy, looking west through doorway from alley; scale in feet (Photographer: Richard Hunter, July 1987).

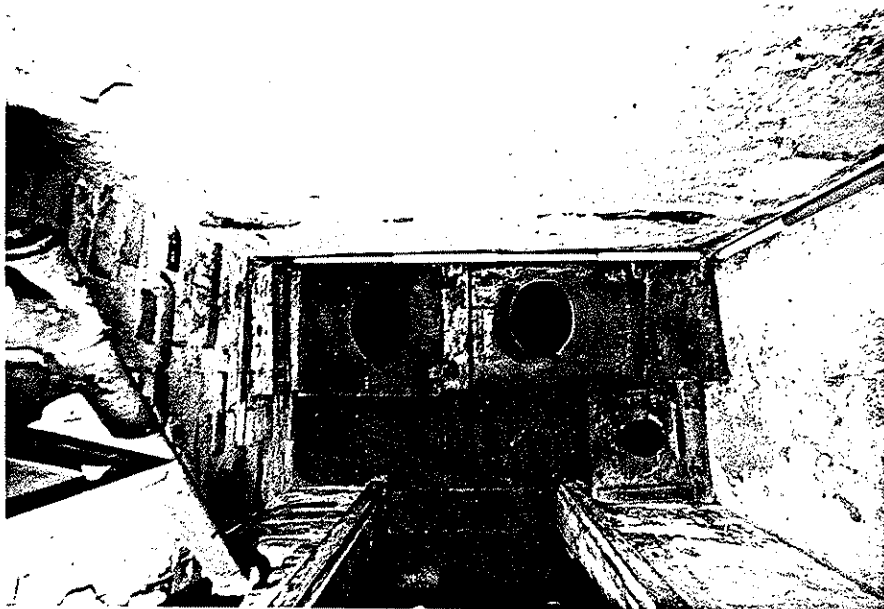
Plate D.4. 10 East State Street: vertical view of three-seater privy; scale in feet (Photographer: Richard Hunter, July 1987).

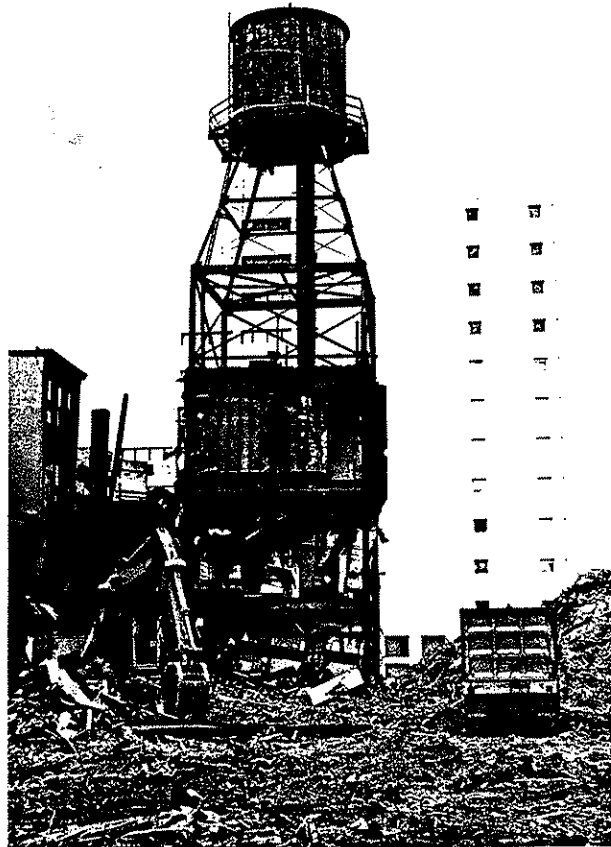
Plate D.5. View of the Dunhams water tower, looking west, taken during the demolition of the block (Photographer: Steven Kaplan, November 1987).

The Dunhams Water Tower is worthy of specific mention as it served as a prominent downtown landmark for 40 years. This structure was erected in 1948 and consisted of a 20,000 gallon wood tank set atop a 35-foot high steel frame tower (City of Trenton Tax Records; Acroterion 1988).

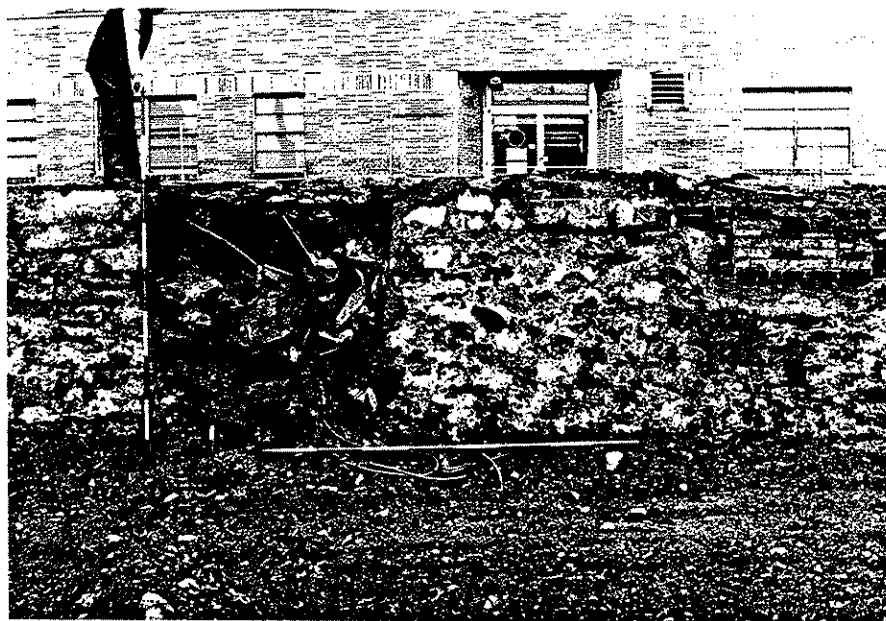
Plate D.6. View looking north, at the north foundation of the mid-1850s wing of the Trenton House; East Hanover Street in background; scale in feet (Photographer: Lynn Rakos, November 1987).

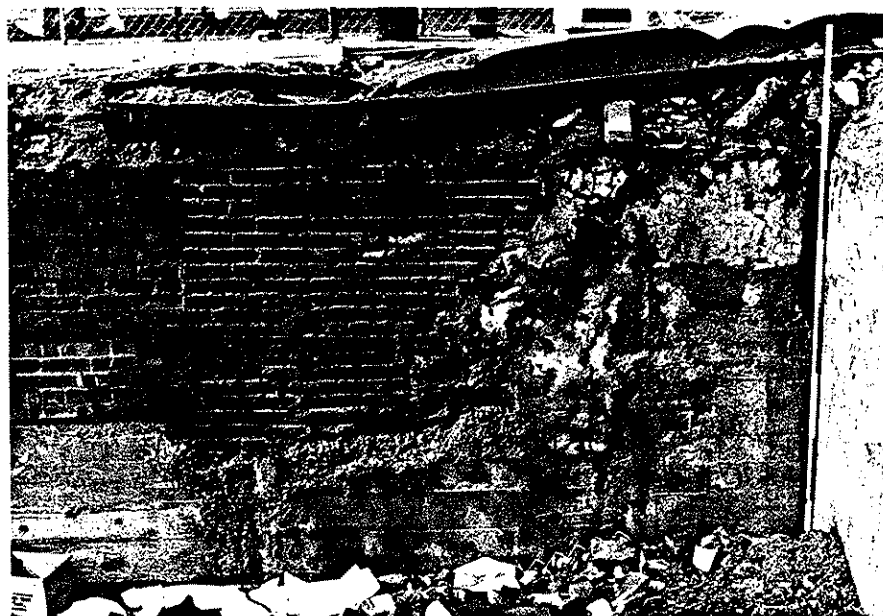
Plate D.8. View looking west at northwest corner foundation of The Trenton House; scale in feet (Photographer: Lynn Rakos, November 1987).

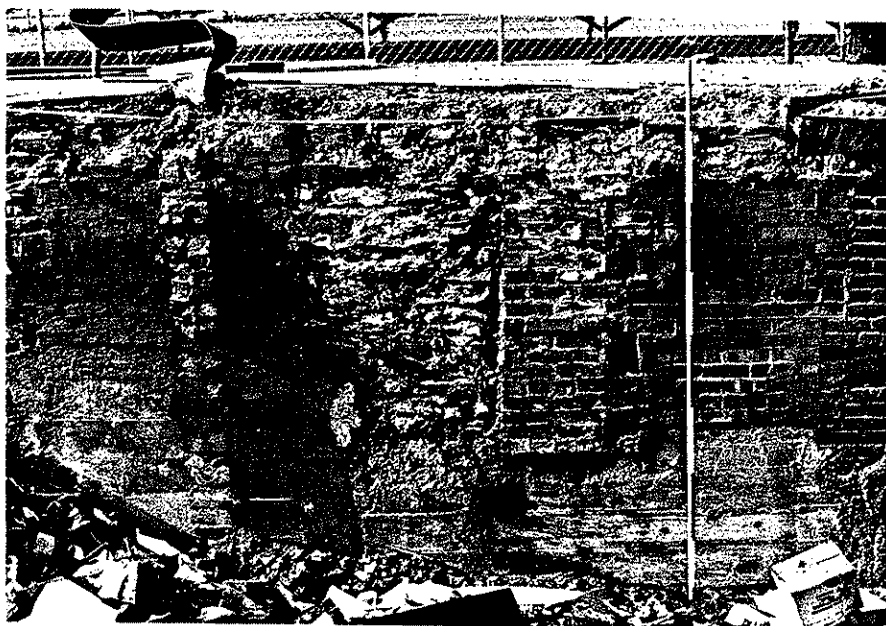
Plate D.9. View looking west at west foundation of the Trenton House property, North Warren Street in background; scale in feet (Photographer: Lynn Rakos, November 1987).

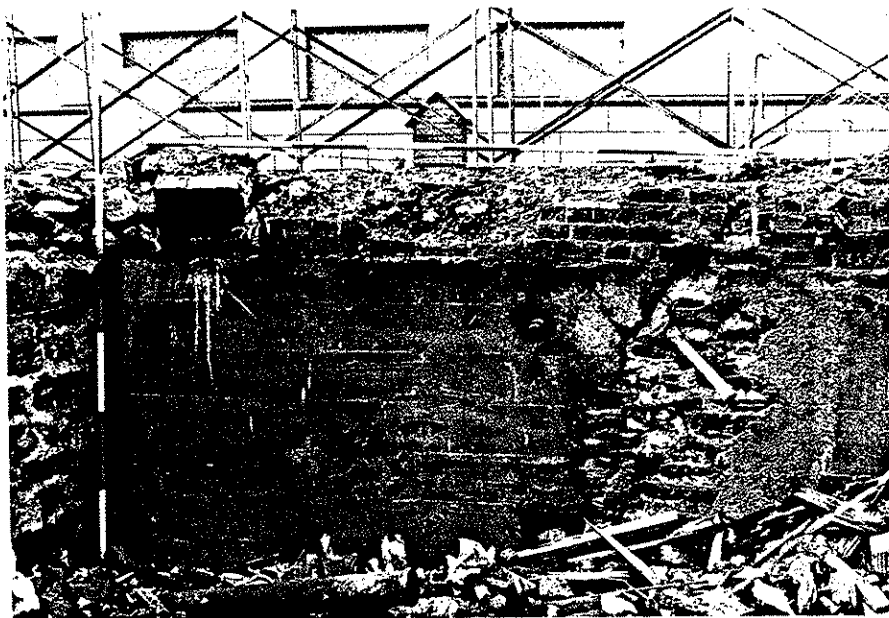
Plate D.10. View looking west at the south-west corner foundation of the main block of the Trenton House; North Warren Street in background; scale in feet (Photographer: Lynn Rakos, November 1987).

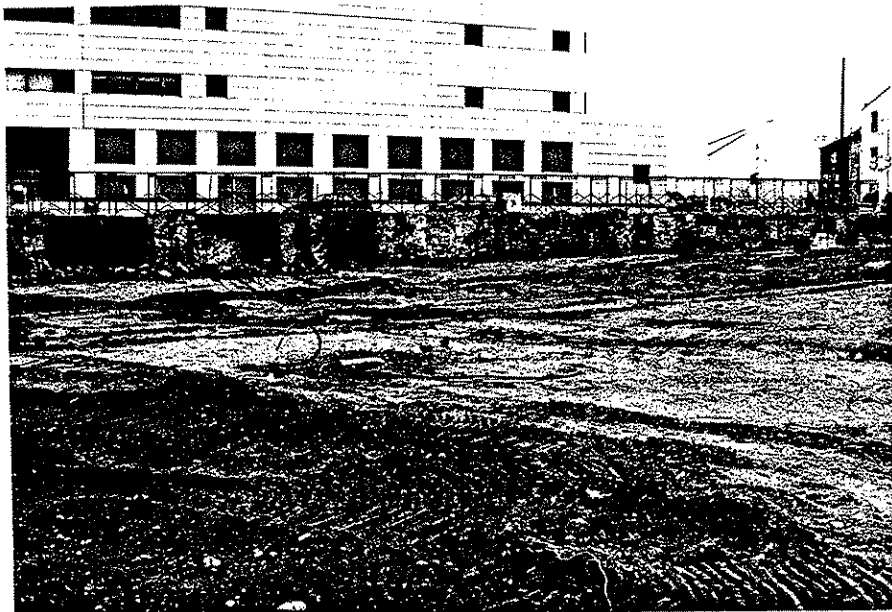
Plate D.11. General view of the demolition of the Dunhams Block, looking southwest; North Warren Street to right of photograph; basements of 14A, 16 and 18 North Warren Street visible in foreground (Photographer: Steven Kaplan, November 1987).

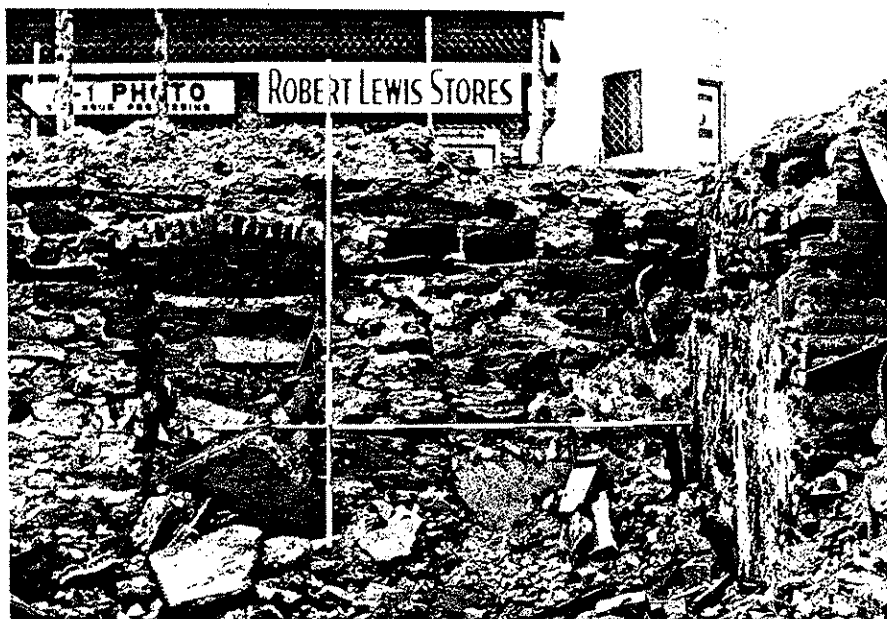
Plate D.13. 2 North Warren Street: view of the southwest corner foundation, looking south, showing blocked opening to possible vault beneath sidewalk; scale in feet (Photographer: Lynn Rakos, November 1987).

The basement walls of virtually all the properties within the Dunhams block displayed evidence of modification, rebuilding, blocked openings, etc. This was especially noticeable in the foundations along the street frontages where original masonry had frequently been patched or rebuilt in stone, brick or concrete. In many instances openings for stairways leading up to the sidewalk had been blocked, although along North Broad and East State Streets there were a number of brick-arched storage vaults that extended beneath the street paving (Plates D.14-D.16). There were only two locations where blocks of soil stratigraphy were observed. These consisted of narrow slivers of cultural strata which survived beneath the alleys between 15 and 17 North Broad Street (Plate D.15) and 12 and 14 North Warren Street.

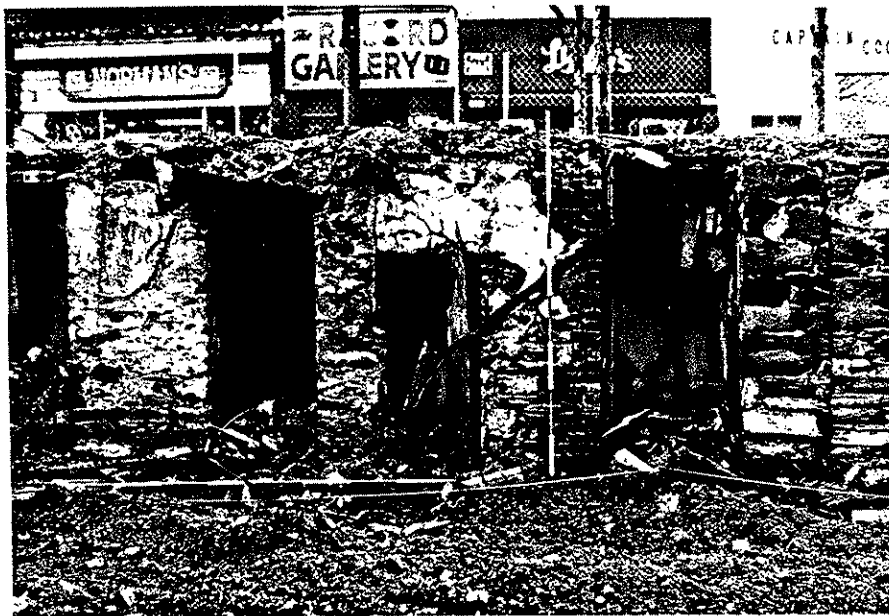
Plate D.14. 8 East State Street: view looking south at south foundation; small doorway in center leads into a stone lined, brick-arched vault located beneath sidewalk; scale in feet (Photographer: Lynn Rakos, November 1987).

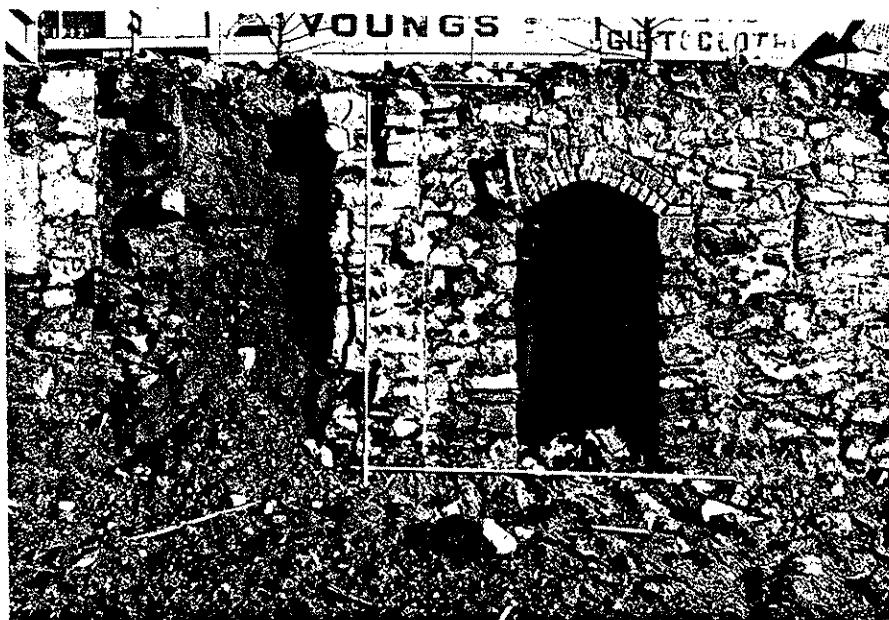
Plate D.15. 15-17 North Broad Street: view looking east at east foundation; vertical area of soil to left of range pole indicates the alleyway between 15 and 17 North Broad Street noted on historic maps; arched doorway at center right leads into stone-lined, brick-arched vault beneath sidewalk; scale in feet (Photographer: Lynn Rakos, November 1987).

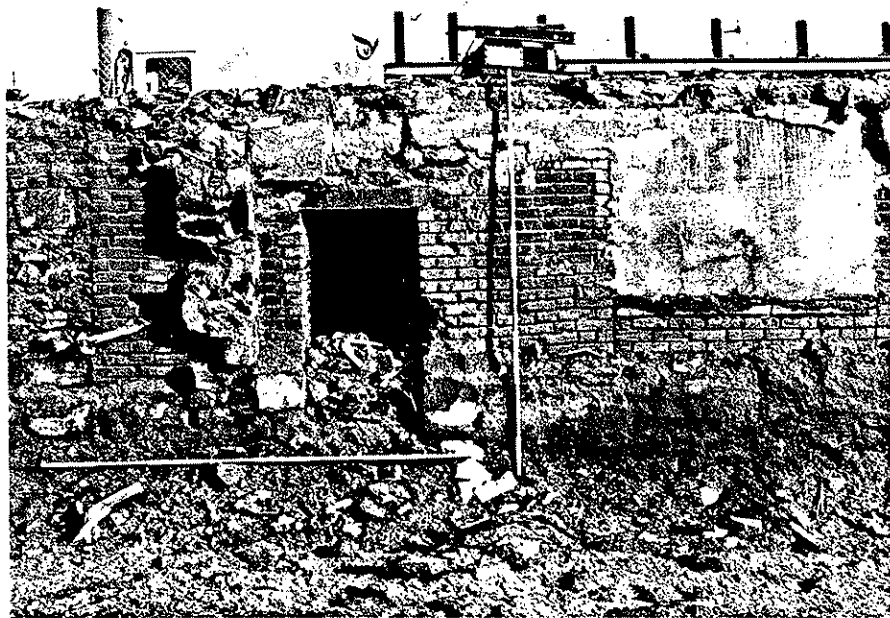
Plate D.16. 17-21 North Broad Street: view looking east at east foundation; opening leads into a stone lined, brick-arched vault located beneath the sidewalk; scale in feet (Photographer: Lynn Rakos, November 1987).
