## B. Archaeology

FIGURE 5.1. TRENTON HOUSE: FIRST FLOOR PLAN A

FIGURE 5.2. TRENTON HOUSE: BASEMENT PLAN AND LOCATIONS OF

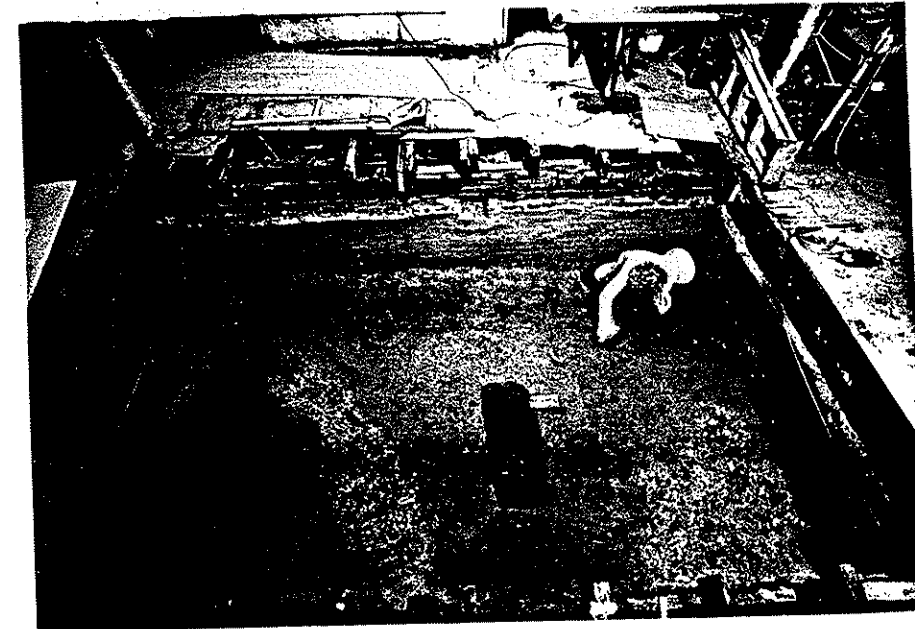
Plate 5.3. Trenton House, Excavation Unit 1: general view of mid-19th century yard deposits looking north; sand base for garden paths visible in left half of unit; dark stain at center bottom is base of c.1860s trash pit; original Phase 1 test trench visible in center of unit (Photographer: Richard Hunter, April 1987).

Immediately northwest and northeast of Excavation Unit 1, enclosed within the floor framing and resting directly on top of the two-phase brick foundation (but not on the later foundation applied to the south), were two cast iron columns (Plates 5.2, 5.3 and 5.18). Two other similar columns were found to the west and east in adjoining rooms within the single-story structure that spanned the hotel yard (Figure 5.1). This line of columns appears to represent part of the final phase of the porch that ran along the south side of the East Hanover Street wing of the hotel overlooking the yard. The underlying brick foundation therefore reflects two separate phases of porch construction: the more recent phase with the cast iron columns probably dating from around the turn of the century; the earlier phase perhaps dating from mid-way through the second half of the 19th century. A still earlier phase of porch construction, assigned to the mid-1850s, was observed in Excavation Unit 2 (see below).

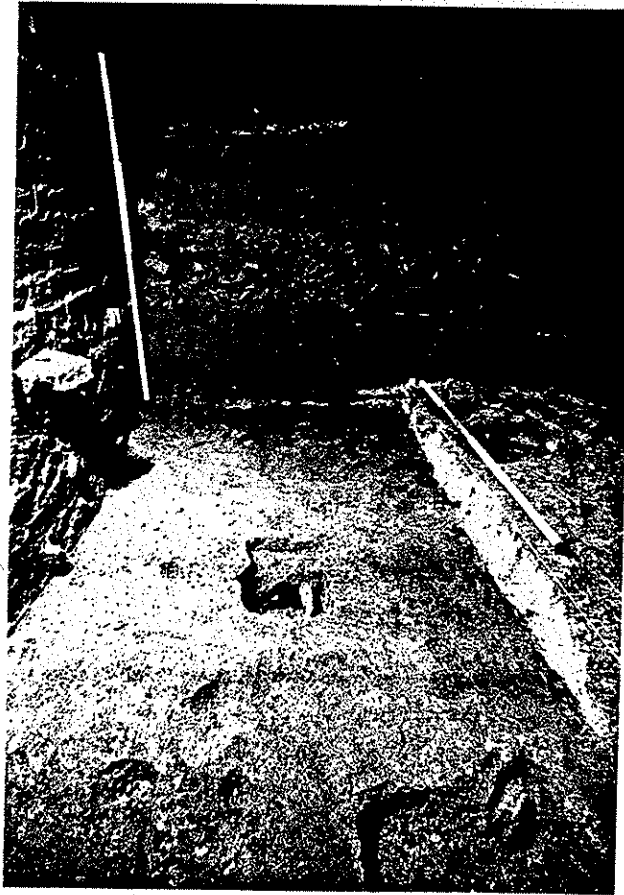
Plate 5.9. Trenton House, Excavation  
Unit 1: view looking east showing  
northern half of unit with 1770s  
mortar-filled construction deposit  
removed; almost four feet of 18th  
and 19th century cultural stratigraphy  
visible in east profile at far end of  
unit; scale in feet (Photographer:  
Richard Hunter, May 1987).

At the base of the garden soils was a very distinctive mortar-filled stratum [1/36, 1B/16] which is interpreted as a deposit related to the construction of the first house on the property in the mid-1770s (Figures 5.4-5.6 and 5.8; Plates 5.8-5.12, 5.19 and 5.20). The artifacts recovered from above and below this level, notably the ceramics, strongly support this identification (Appendix C.i). The soils immediately below this stratum [1/37, 1A/27, 1A/29] also contained some mortar, evidently trodden into the ground surface during construction, while a number of postholes (probably from temporary structures erected during the construction phase) were observed cutting through this level [1/33, 1/34, 1/35, 1/38] (Plates 5.8 and 5.9).

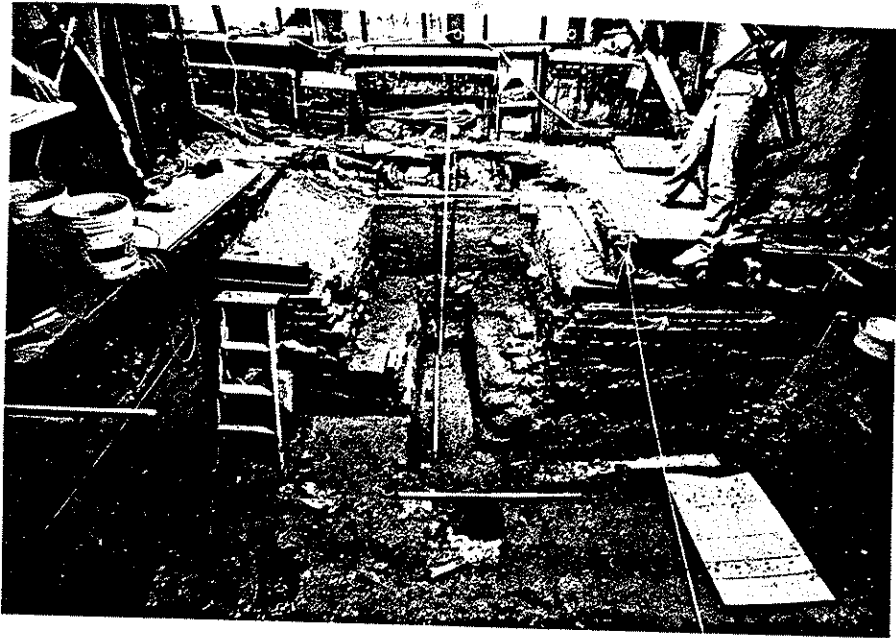
Plate 5.14. Trenton House, Excavation Unit 1A: general view looking south showing unit during excavation of early 19th century deposits; robber trench for north-eastern corner of late 18th century outbuilding visible in center; scale in feet (Photographer: Richard Hunter, August 1987).

In Excavation Unit 1A and the southwest corner of Excavation Unit 1 the mid-19th century garden deposits sealed a well-defined trench filled with compact rubble [1/26, 1A/19] (Figures 5.4, 5.5 and 5.7; Plates 5.4, 5.6-5.8, 5.14-5.17). This trench represented the robbing of a square or rectilinear foundation, the northeast corner of which was located close to the junction of Excavation Units 1 and 1A. Stratigraphic relationships and associated artifacts date this robbing action to the late 1830s at the earliest, although the building itself is believed to have been erected in the late 18th or very early 19th centuries.

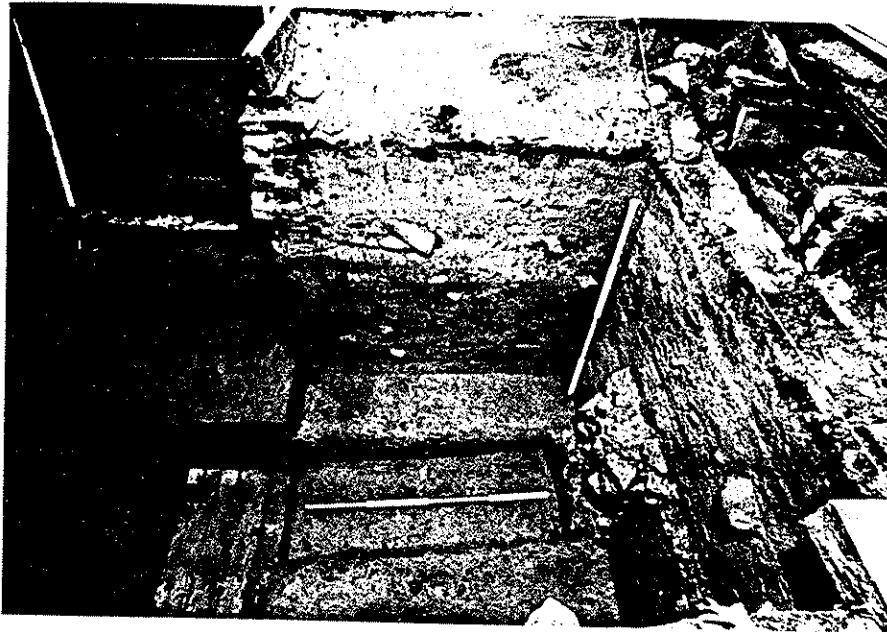
Plate 5.15. Trenton House, Excavation Unit 1A: general view looking east upon completion of excavation; horizontal scale pole rests on subsoil in base of robber trench for east wall of late 18th century outbuilding; profile in center of view to left of vertical scale pole shows accumulation of mid-18th through mid-20th century cultural stratigraphy consisting mostly of yard build-up and garden soils; scale in feet (Photographer: Richard Hunter, August 1987).

While the southernmost of the two brick foundations [1/2, 1A/35] was clearly constructed in a single building episode (Plates 5.13 and 5.15), the northern wall was considerably more complex. The south side of this foundation [1/5] had been applied in the early 20th century against an earlier brick foundation [1B/2] that, when viewed from the north (Plate 5.20), itself showed two separate phases of construction. The lower seven courses of this ten-course brick wall were of one "build", comprising five rows of stretchers sandwiched between two rows of headers. In a separate building action three additional courses of stretchers had then been added on top of the lower seven courses, bringing the wall to its full height. This two-phase wall supported the Chinese restaurant floor via a wooden sill beam and a series of uncharred joists, indicating that these timbers were part of a mid- to late 20th-century replacement (post-fire) framing system.

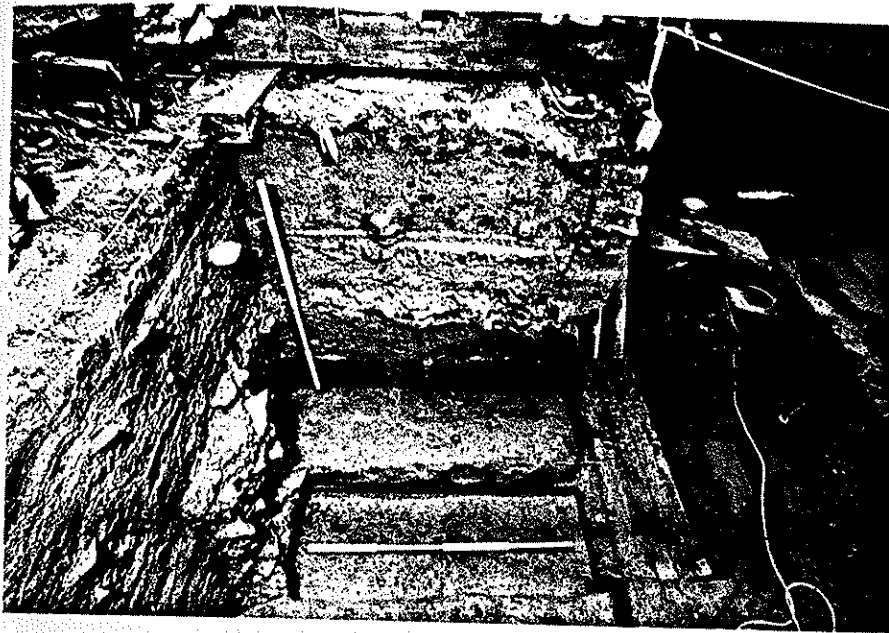
Plate 5.17. Trenton House, Excavation Unit 1A: general view looking west upon completion of excavation; horizontal scale pole rests on subsoil in base of robber trench for east wall of late 18th century outbuilding; profile in center of view to right of vertical scale pole shows destruction deposit associated with late 18th century outbuilding and accumulation of mid-18th through mid-20th century cultural stratigraphy consisting mostly of yard build-up and garden soils; scale in feet (Photographer: Richard Hunter, August 1987).

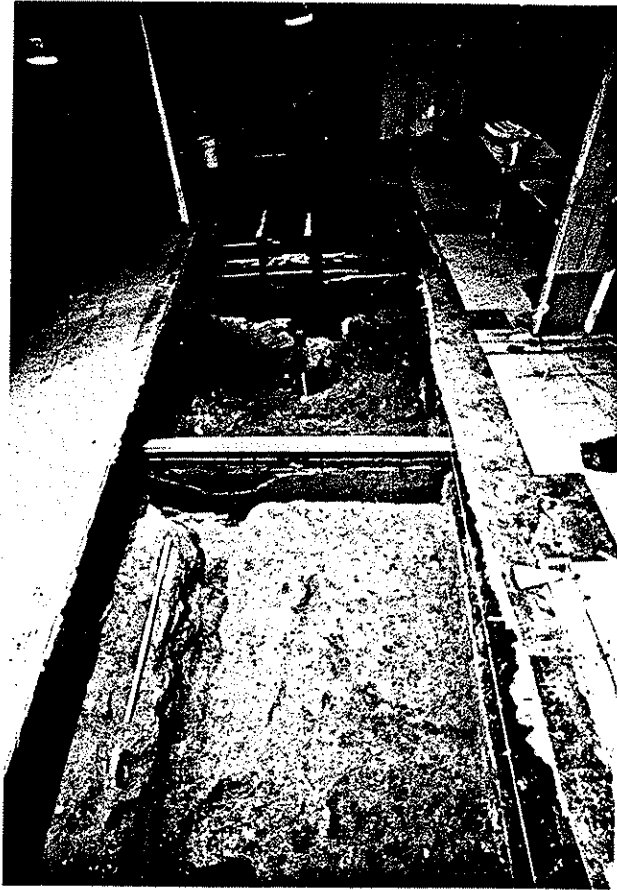
Plate 5.21. Trenton House,  
Excavation Unit 2: general view  
looking north during early stages  
of excavation; brick walls supported  
20th century Chinese restaurant  
flooring; subsidence in foreground  
to right of scale pole is due to  
underlying ice house; late 19th  
century cast iron porch column  
visible at top left; rear wall of  
East Hanover Street hotel wing  
beyond; scale in feet (Photographer:  
Richard Hunter, April 1987).

Two east-west brick walls [2/2, 2/4, 2A/2, 2A/4] were immediately visible within Excavation Unit 2 once the floor was removed (Plate 5.21). These were continuations of the same two foundations observed in Excavation Units 1, 1A and 1B and represent the foundations for the single-story structure erected over the former hotel yard sometime between 1908 and 1927. As part of this same building operation a concrete-capped brick wall [2/6] was also applied against the south wall of the yard (also the south wall of the ice house) (Figure 5.9).

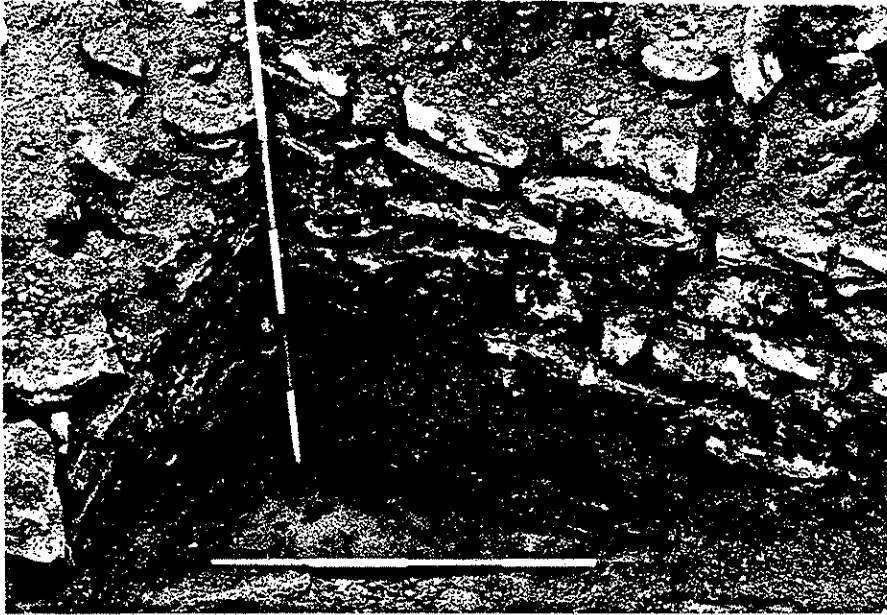
Plate 5.24. Trenton House: view looking northwest showing base of northwest corner of mid- to late 19th century ice house following demolition of all buildings within the Dunhams Block; scale poles rest on natural sands and gravels; scale in feet (Photographer: Richard Regensburg, December 1987).

Removal of the fill from the inside of the ice house proved to be an extremely hazardous task as the material was loose and deep, so deep in fact that the full depth of the structure was not established until after the Dunhams Block was demolished. In December, 1987, with the assistance of a backhoe, it was determined that the ice house extended to a depth of approximately 15 feet below the top of the stone foundation (Plate 5.24). The below-ground capacity of this structure was therefore around 3,000 cubic feet.

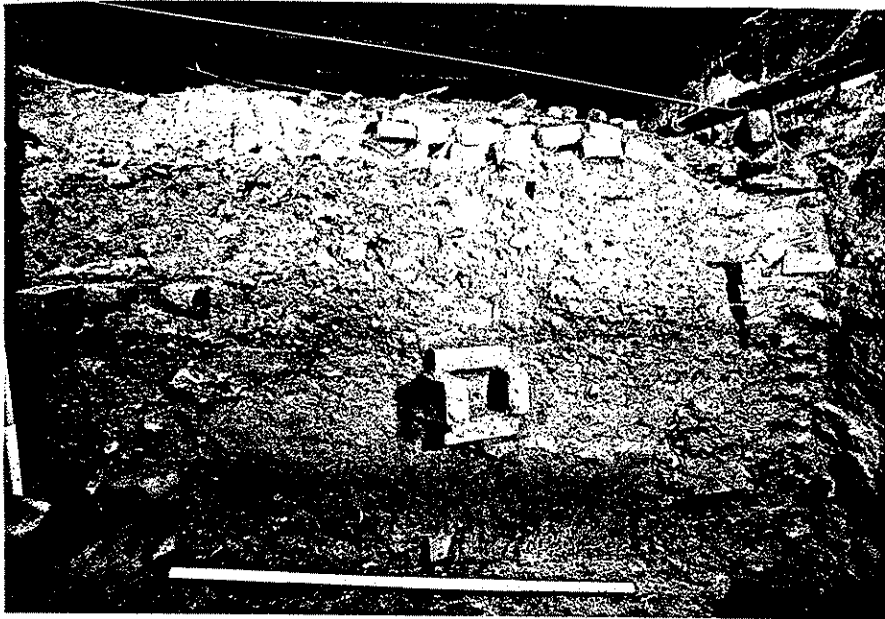
Plate 5.32. Trenton House, Excavation Unit 2B: view looking west showing west profile; horizontal scale pole rests on subsoil; at right the builders' trench for mid-19th century East Hanover Street hotel wing is visible cutting into the subsoil and earlier yard deposits; stratigraphic sequence from base of profile upwards includes late 18th and early 19th century yard build-up and garden soils, early 19th century brick path and sand bedding at center left [two feet above base of unit], mid-19th century brick drain cut into earlier deposits, and mid-19th through early 20th century yard build-up; scale in feet (Photographer: Richard Hunter, August 1987).

Also contemporary with this building phase were the original porch foundation features discussed above and a brick drain [2B/9] that ran west southwest into the yard area and away from the hotel building (Figures 5.9 and 5.10; Plates 5.30-5.32). This drain remains something of a mystery as no trace of it was observed in Excavation Unit 1 and it clearly did not relate to any of the other drains found in Excavation Unit 2. It presumably fed into an undiscovered septic somewhere between these two excavation units.

Sealed beneath deposits contemporary with the hotel's mid-1850s construction, and cut by the ice house construction levels of circa 1835, were fragments of a yard surface and yard-related features dating from the late 18th and early 19th centuries (Figures 5.9, 5.10, 5.12 and 5.13; Plates 5.25, 5.26, 5.32 and 5.33). A small area of brick paving [2B/12] and an associated stone slab [2/54] appeared to correspond, both stratigraphically and in terms of general elevation, with the lower of the two brick walks observed in Excavation Units 1 and 1B. This surface and its sand and gravel base [2/34, 2B,13] lay above and adjacent to a garden or yard soil [2/37, 2/38, 2B/22] that produced late 18th- and early 19th-century cultural materials.
