## B. ARCHAEOLOGY

Phase 1 archaeological investigation of 12 and 14 North Warren Street (and the alley in between) involved a thorough inspection of the basements, ground floors and outside portions of these properties and limited subsurface testing to establish whether intact archaeological deposits still survived in those areas where basements did not appear to be present. Phase 2 archaeological investigation involved the excavation of four units in areas where potentially significant archaeological resources were encountered. Three of these units were located inside the rear, uncellared portion of 12 North Warren Street. The fourth unit was located at the rear end of the alley between 12 and 14 North Warren Street (Figure 6.1).

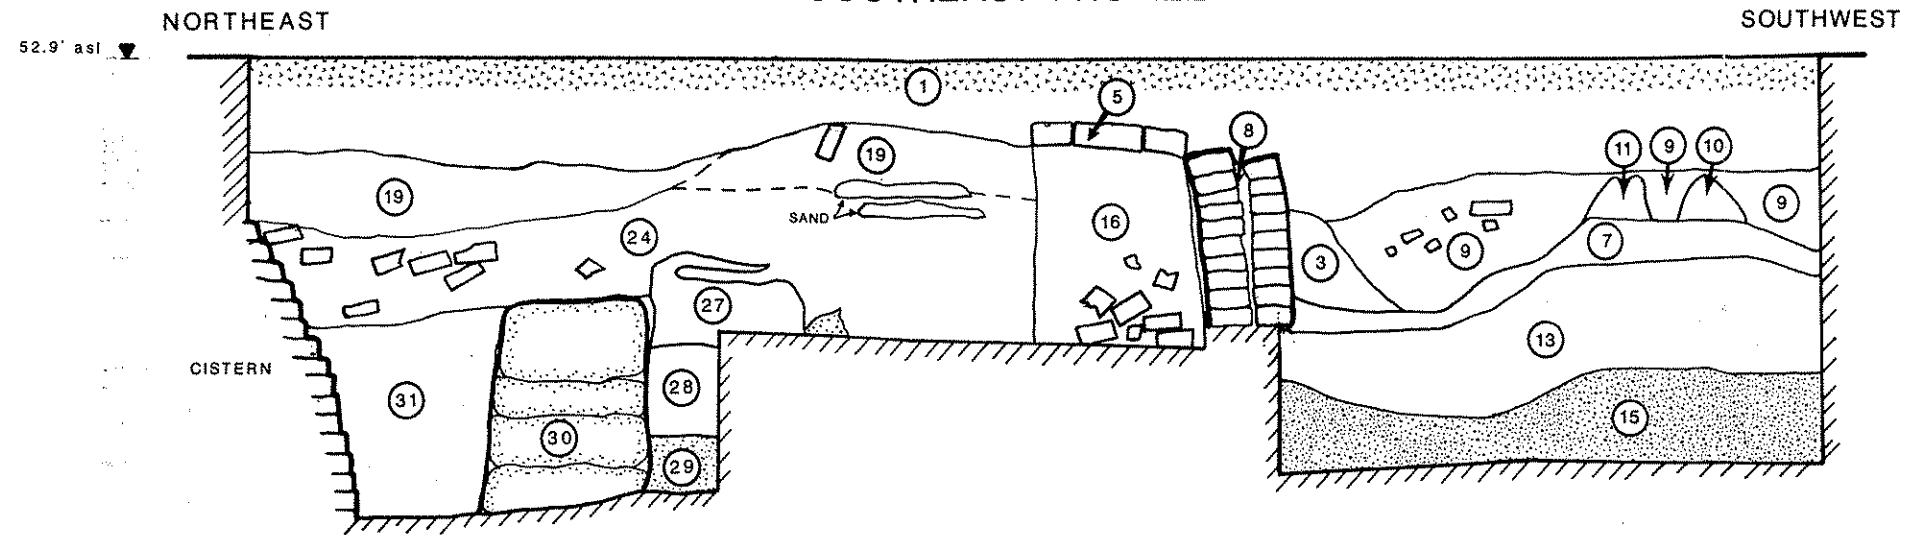
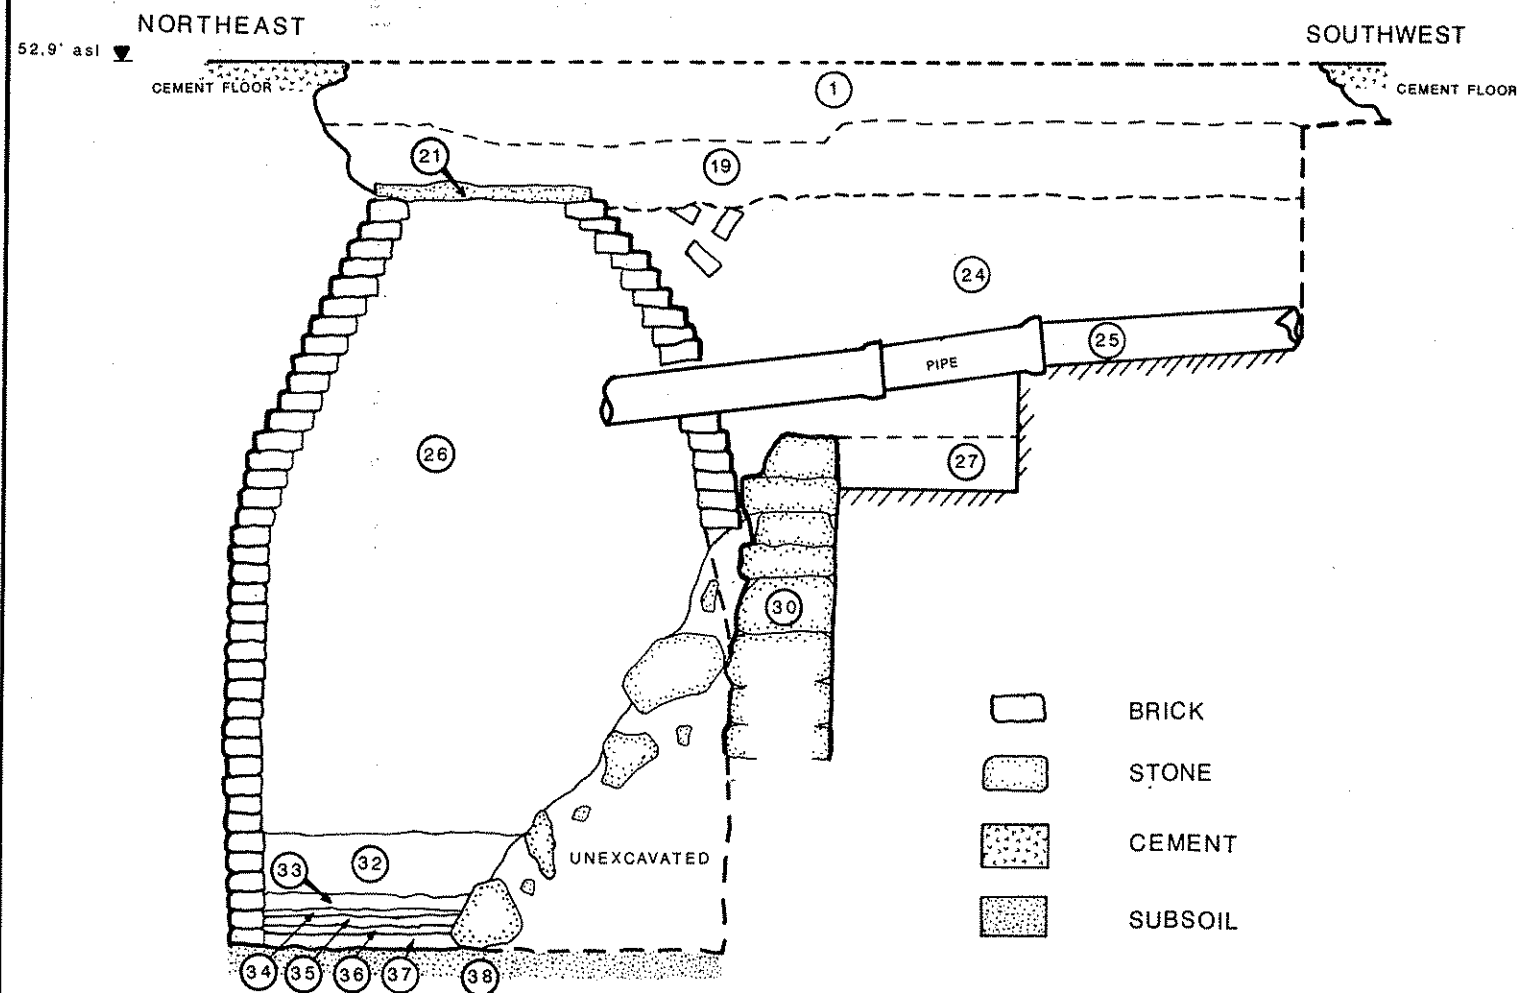
FIGURE 6.4. 12 NORTH WARREN STREET: EXCAVATION UNIT A

SOUTHEAST PROFILE

CROSS-SECTION OF CISTERN

- Context 1 - floor of first floor rear room [early 20thc]
- Context 3 - trench for pipe [late 19th/early 20thc]
- Context 5 - walkway or yard [mid-19th thru early 20thc]

- Context 7 - yard build-up/garden soil [late 18th thru mid-19thc]
- Context 8 - NE corner of brick foundation for earlier rear wing [mid-19thc]
- Context 9 - fill [late 19thc]

- Context 10 - see context 9
- Context 11 - see context 9
- Context 13 - yard build-up/garden soil [mid-18th thru early 19thc]
- Context 15 - subsoil
- Context 16 - fill of pipe trench [mid-/late 19thc]

- Context 19 - fill [mid-/late 19thc]
- Context 21 - stone cap for cistern [early 1820s]
- Context 24 - fill of pipe trench [early 1820s]
- Context 25 - drain pipe flowing into cistern [early 1820s]

- Context 26 - cistern fed by drain [25], capped by slab [21] and set into natural river gravels [38] [early 1820s]
- Context 27 - yard build-up/garden soil [late 18th thru mid-19thc]

- Context 28 - yard build-up/garden soil [mid-18th thru early 19thc]
- Context 29 - subsoil
- Context 30 - stone wall, ?outbuilding foundation or stone cistern [?late 18th/early 19thc]

- Context 31 - fill of builders trench for cistern [early 1820s]
- Context 32 - cistern fill [early 1820s]
- Context 33 - cistern fill [early 1820s]
- Context 34 - cistern fill [early 1820s]

- Context 35 - cistern fill [early 1820s]
- Context 36 - cistern fill [early 1820s]
- Context 37 - cistern fill [early 1820s]
- Context 38 - subsoil

Excavation Unit A (Matrix 6.1; Figures 6.3 and 6.4; Plates 6.2-6.10; Appendices B.ii and C.ii), 4 by 18 feet in plan, was laid out diagonally, northeast-southwest, across the rear room of 12 North Warren Street (Figure 6.1). The excavation unit was laid out in this way to provide optimum coverage of the area available for excavation within the room without going so far as to excavate the room in its entirety.

Immediately outside the northeastern corner of the rear addition a ceramic drain [16, 17] gathered water from the roof and fed an unknown destination to the northwest. This drain, which was sealed by the brick yard surface, was either contemporary with the rear addition or was installed sometime in the very late 19th- or very early 20th centuries. If it dated from prior to the 1890s the pipe may have fed into a cistern between the rear addition and the alley, but if it dated from the turn-of-the-century (perhaps the more likely explanation), it probably connected with the city-wide storm drain system (Figures 6.3 and 6.4).

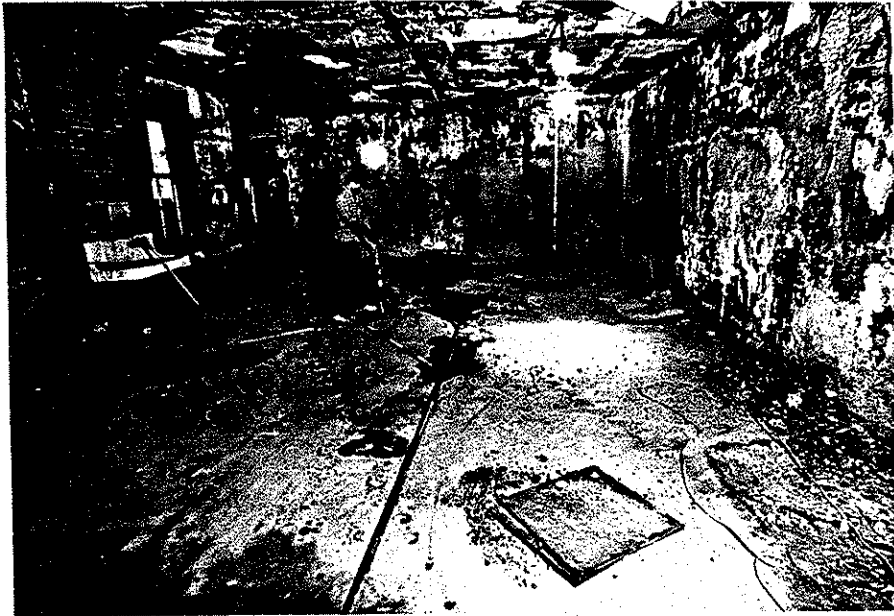
Plate 6.2. 12 North Warren Street, Excavation Unit A:  
view looking east showing cement floor being removed by  
jackhammer; scale in feet (Photographer: Richard Hunter,  
August 1987)..

The cement floor and its rubble base [1] were removed with a jackhammer, picks and shovels (Plate 6.2). Beneath this material was a discontinuous layer of fill [9] (probably a make-up level for the 1908-27 construction) and remains of a brick foundation [8] and brick yard surface or path [5] (Plate 6.3). These latter features appear to be of mid-19th century date, the foundation evidently being the remains of a one-story rear addition that was in existence certainly by the 1880s and perhaps even before 1870 (Figures 4.13 and 4.15-4.20). This addition did not contain a basement and was erected over a shallow crawl space. Its function remains unknown, although the structure appears to have been built during the period that 12 North Warren Street was a jewelry store and it may therefore have fulfilled some commercial purpose. The upper deposits inside the rear addition had been much disturbed by the early 20th-century construction and the installation of water pipes [4, 14], but below this zone was a yard soil, up to 18 inches thick, that contained a mixture of late 18th- and early 19th-century cultural materials [7, 12, 13] (Plates 6.4 and 6.5).

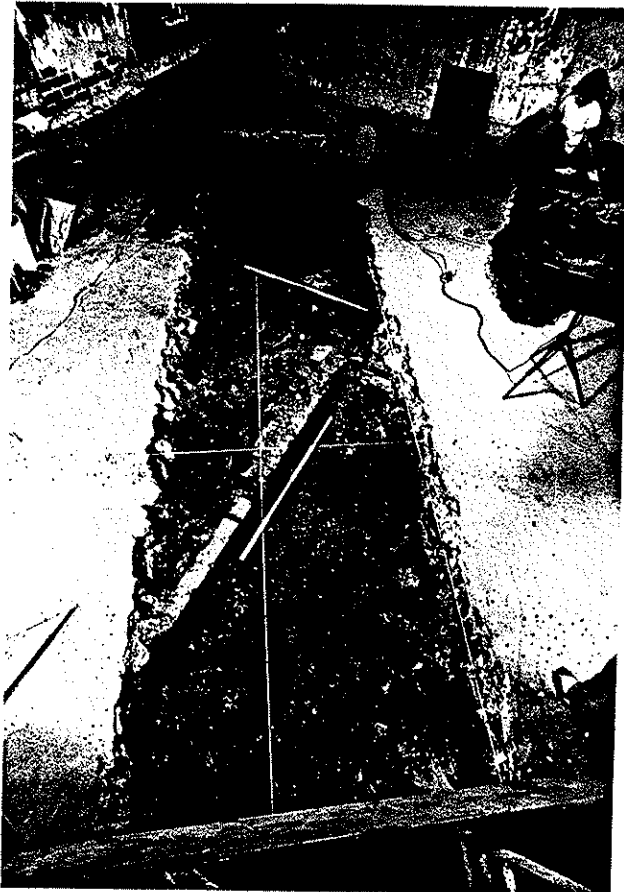
Plate 6.3. 12 North Warren Street,  
Excavation Unit A: general view  
looking northeast showing unit during  
early stages of excavation; northeast  
corner of foundation for mid-19th  
century rear addition to early 1820s  
dwelling visible in center of unit;  
scale in feet (Photographer: Richard  
Hunter, August 1987).

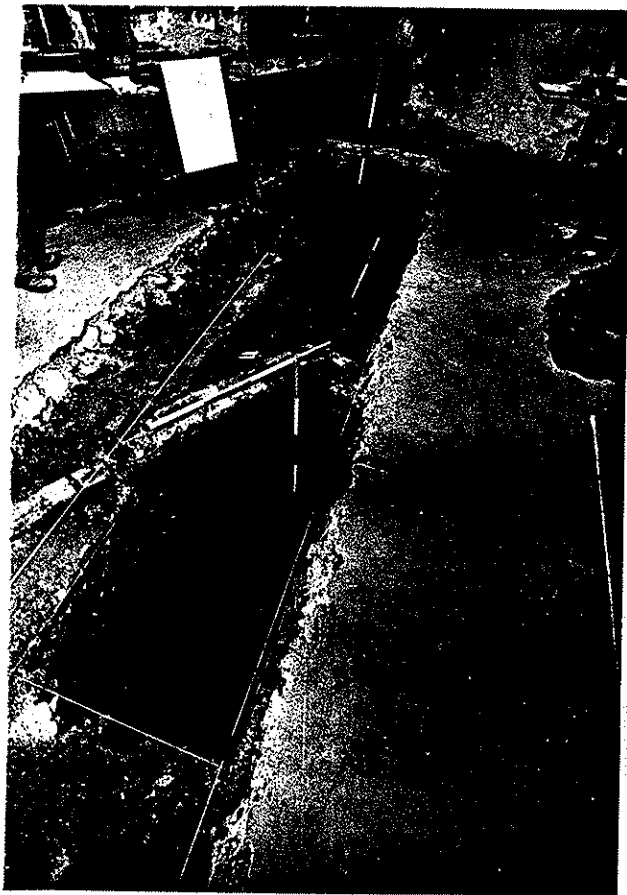
Plate 6.4. 12 North Warren Street,  
Excavation Unit A: general view  
looking northeast showing northeast  
corner of foundation for mid-19th  
century rear addition fully exposed;  
vertical scale pole in angle of  
foundation rests on subsoil; slab  
at far end of trench covers top of  
early 19th century brick cistern;  
scale in feet (Photographer: Richard  
Hunter, August 1987).

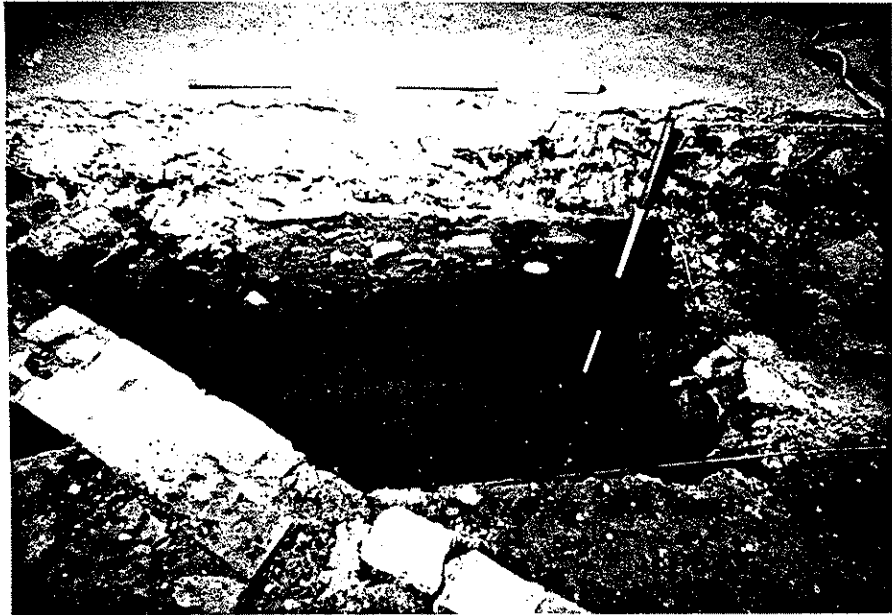
Plate 6.5. 12 North Warren Street, Excavation Unit A: view looking southeast showing southwestern end of unit; northeast corner of foundation for mid-19th century rear addition at left; vertical scale pole rests on subsoil; 18th and early 19th century yard soils visible in bottom two feet of profile; these are overlaid by later 19th century yard build-up and fill; scale in feet (Photographer: Richard Hunter, August 1987).

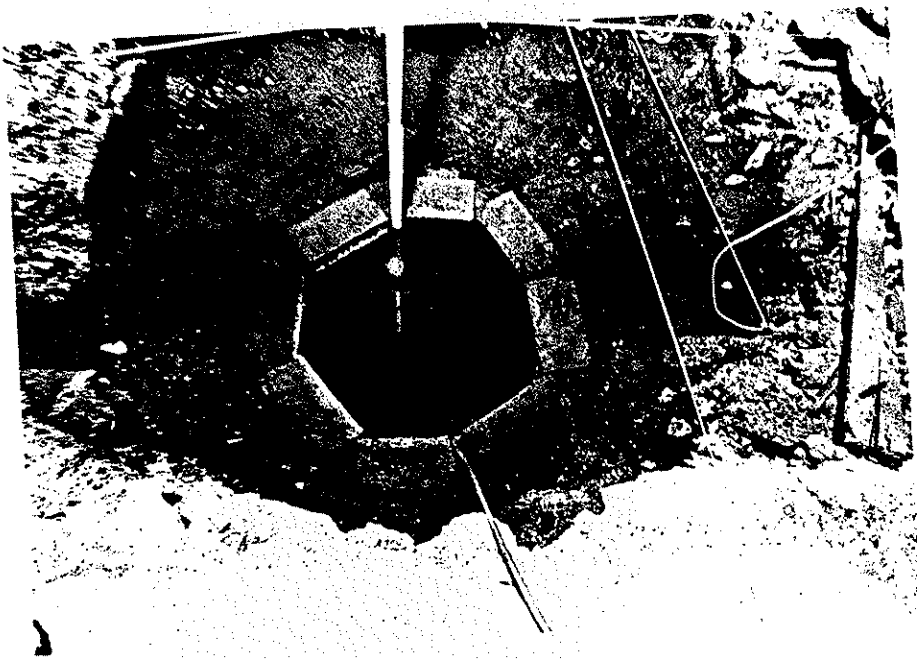
Plate 6.6. 12 North Warren Street, Excavation Unit A:  
view looking southwest showing northeast end of unit  
and top of early 19th century brick cistern with slate  
slab removed; note ceramic drain feeding into cistern  
behind scale pole; scale in feet (Photographer: Richard  
Hunter, August 1987).

The dominant feature outside the rear addition in the rest of Excavation Unit A was a second, earlier ceramic drain [24, 25] which fed into a finely-constructed, beehive-shaped brick cistern [26, 31] located in the northeastern corner of the room (Plates 6.6-6.8). This drain may have been modified in the mid-19th century to gather rain water from the roof of the one-story rear addition constructed at that time, but, on the basis of the artifacts recovered from the trench for the pipe further to the northeast and from the builders trench for the cistern, these features appear to have been part of the early 1820s construction phase. The cistern is presumably contemporary with the building of Stephen Rose's house and was designed to collect rain water from the southeastern corner of the two-story, brick rear section of this structure (Figures 4.13 and 4.15-4.20).

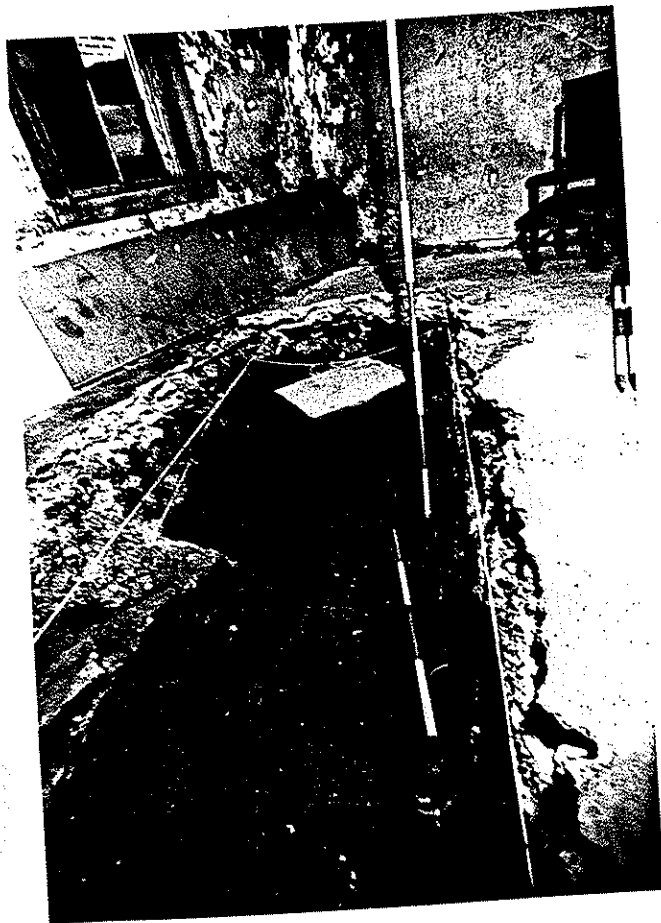
Plate 6.7. 12 North Warren Street,  
Excavation Unit A: general view  
looking northeast showing northeast  
end of unit; ceramic drain in fore-  
ground feeds into early 19th century  
brick cistern at far end of unit;  
scale in feet (Photographer: Richard  
Hunter, August 1987).

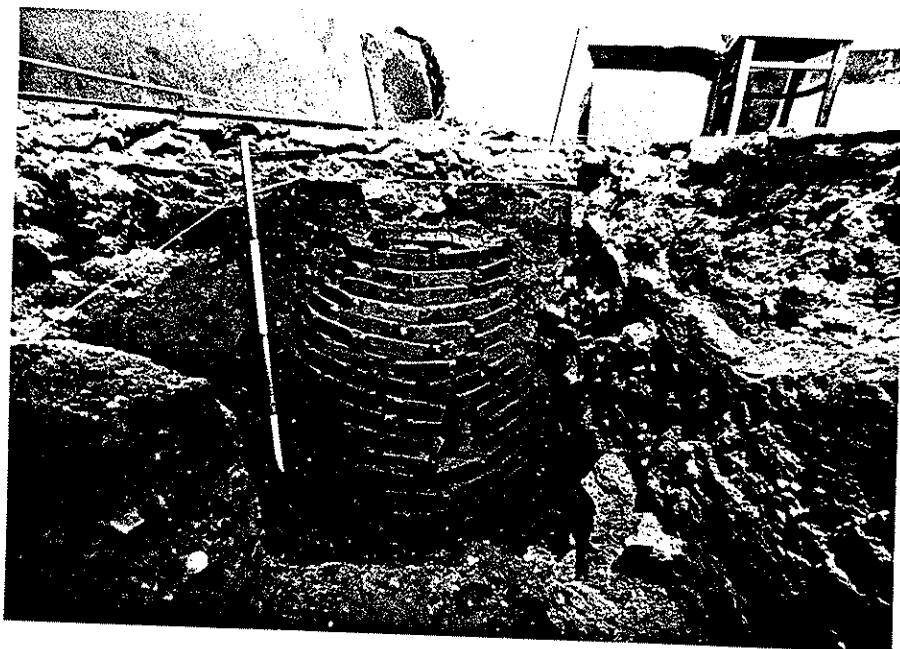
Plate 6.8. 12 North Warren Street, Excavation Unit A:  
view looking northeast showing early 19th century brick  
cistern; ceramic drain has been removed; scale in feet  
(Photographer: Richard Hunter, August 1987).

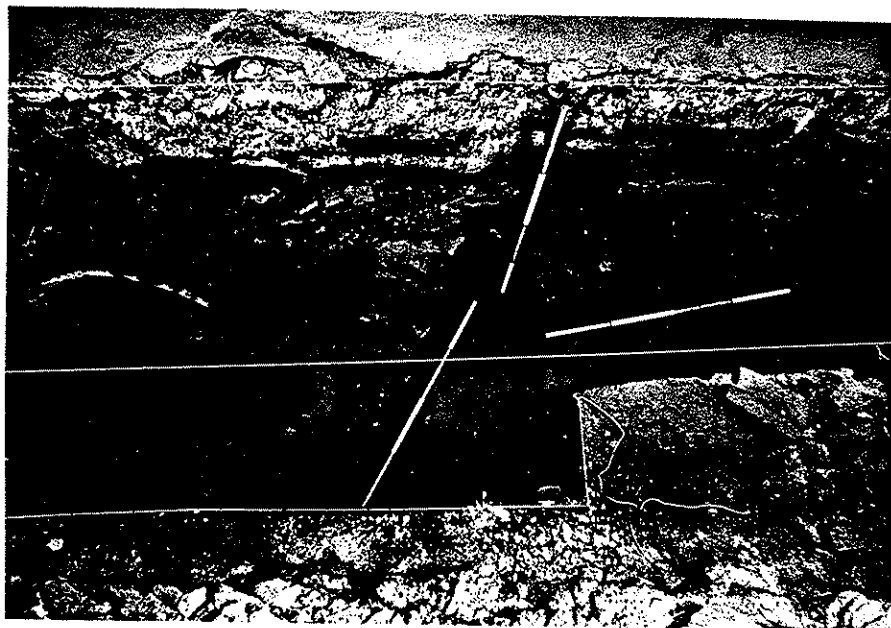
Plate 6.9. 12 North Warren Street, Excavation Unit A: view looking southeast showing northeast end of unit; early 19th century brick cistern at left has been partially removed; note that the cistern cuts and has been built into an earlier stone foundation visible in the center of the view; a section of the ceramic drain feeding the cistern can be seen in base of unit; northeast corner of mid-19th century rear addition just visible at right; scale in feet (Photographer: Richard Hunter, August 1987).

The most tantalizing feature of the cistern was the fact that it had been constructed up against and incorporated part of an earlier mortared stone foundation [30] (Plates 6.9 and 6.10). This section of foundation ran north-south and connected with a length of east-west walling discovered in Excavation Unit B [context 28] (the southwest corner of this structure was just discernible in the northwestern corner of Excavation Unit B). While the east-west dimension of this foundation is unknown, the property boundaries in force in the early 19th century require that it probably measured no more than 10 to 12 feet from north to south.

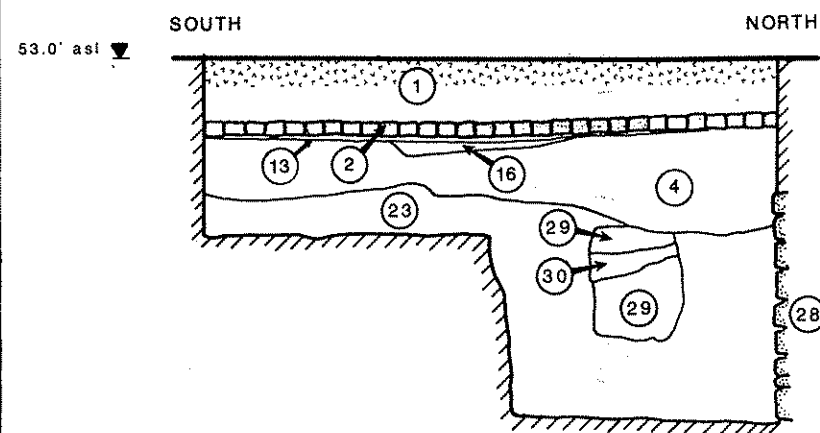
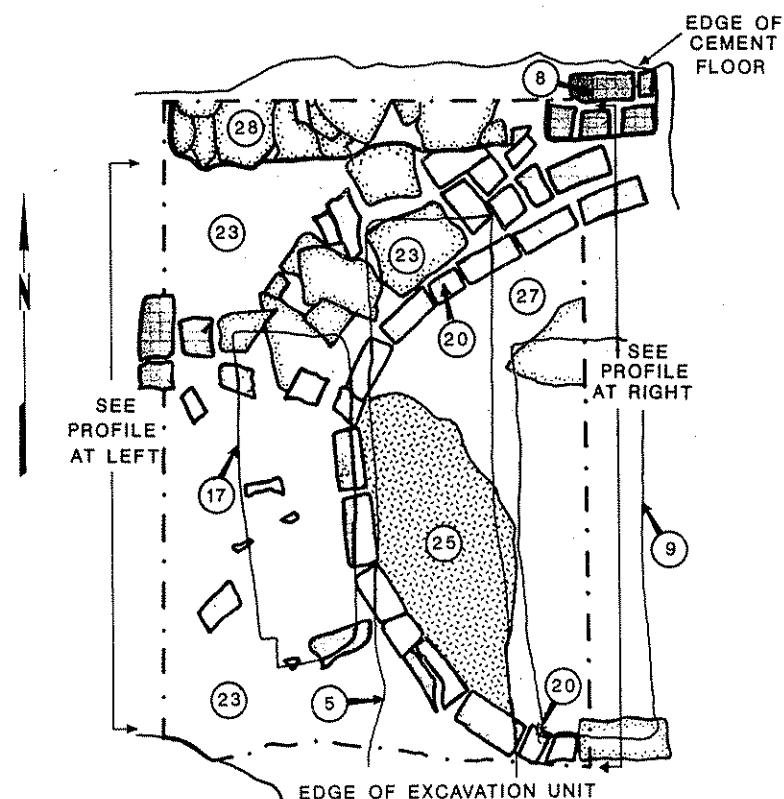
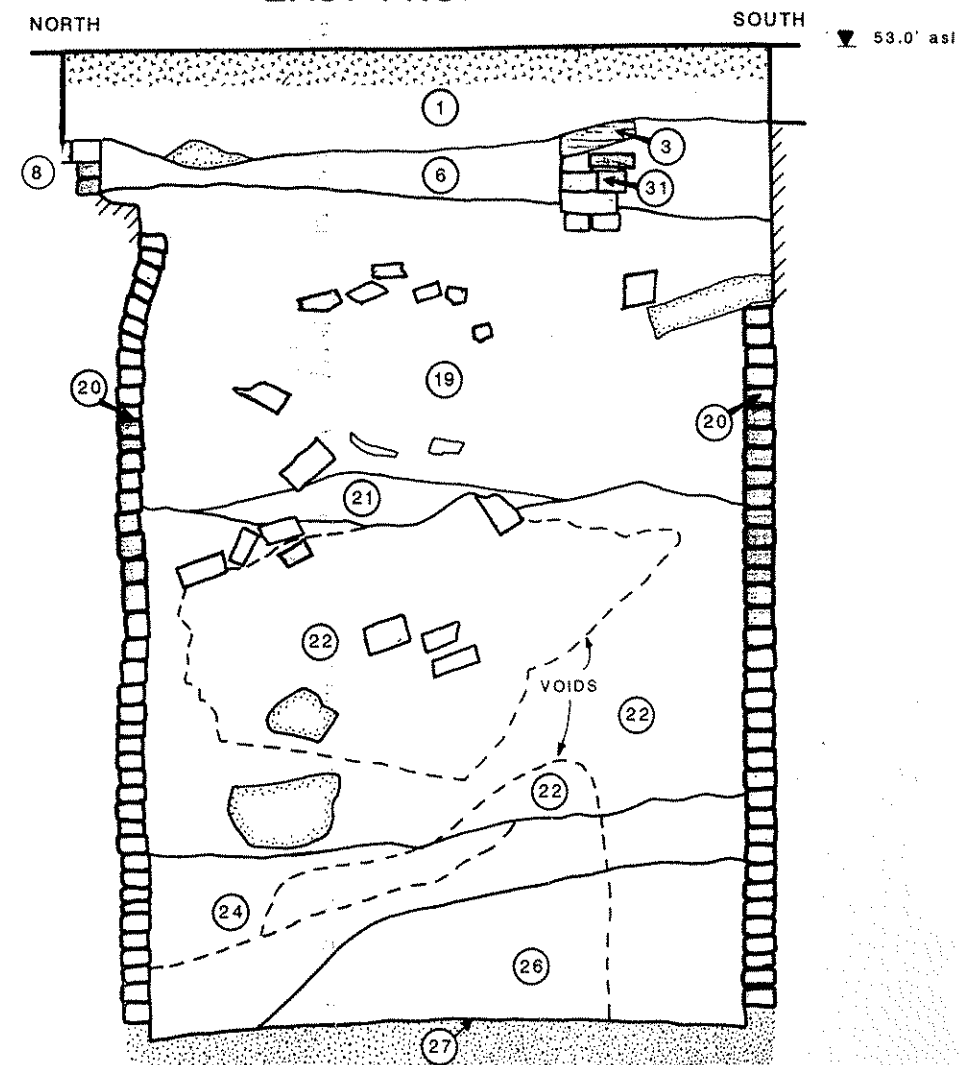
FIGURE 6.5. 12 NORTH WARREN STREET: EXCAVATION UNIT B

WEST PROFILE

PLAN

EAST PROFILE

- Context 1 - floor of first floor rear room [early 20thc]
- Context 2 - brick yard surface [late 19th/early 20thc]
- Context 3 - underpinning for cement floor [1] [early 20thc]

- Context 4 - fill [late 19thc]
- Context 5 - stone cap for cistern [late 19thc]
- Context 6 - fill/leveling deposit [early 20thc]
- Context 8 - ?underpinning for cement floor [1] [early 20thc]

- Context 9 - stone cap for cistern [late 19thc]
- Context 13 [16] - minor leveling deposit for brick surface [2] [late 19thc]
- Context 16 - see context 13

- Context 17 - stone cap for cistern [late 19thc]
- Context 19 - cistern fill [late 19thc]
- Context 20 - brick lining of cistern [mid-19thc]
- Context 21 - cistern fill [late 19thc]

- Context 22 - cistern fill [late 19thc]
- Context 23 [29] [30] - builders trench for cistern [mid-19thc]
- Context 24 - cistern fill [late 19thc]
- Context 25 - boulder (bedrock)

- Context 26 - cistern fill [late 19thc]
- Context 27 - cistern floor
- Context 28 - stone wall, southwest corner of ?outbuilding foundation or stone cistern [?late 18th/early 19thc]

- Context 29 - see context 23
- Context 30 - see context 23
- Context 31 - ?underpinning for cement floor [1] [early 20thc]

Excavation Unit B (Matrix 6.2; Figure 6.5; Plates 6.11-6.16; Appendices B.ii and C.ii) measured 4.5 by 7 feet in plan and was located in the southeast corner of the rear room of 12 North Warren Street on the assumption that this would be a likely spot for privies, trash pits, cisterns, wells and the like (i.e., features that might be expected to contain large concentrations of artifacts) (Figure 6.1).

The brick yard surface was laid on top of a variety of fill deposits [4, 7, 10, 13-16] and partially sealed a group of three large stone slabs [5, 9, 17] that served as capstones for an eight-foot-deep brick-lined cistern [20] (Plates 6.12-6.14). Probably circular in plan and roughly six feet in diameter, this feature was laid within a large construction cut whose fill [23, 29, 30] contained mid-19th century and earlier cultural materials. This cistern is interpreted as a larger replacement for the early 19th-century cistern found in Excavation Unit A. Unlike its predecessor, this second cistern had been filled with debris upon its abandonment (Plate 6.15). Based on the date of the cultural materials, notably the glassware, contained in these fill deposits, the cistern appears to have gone out of use around the turn of the century, probably circa 1895-1905 (Appendix C.ii).

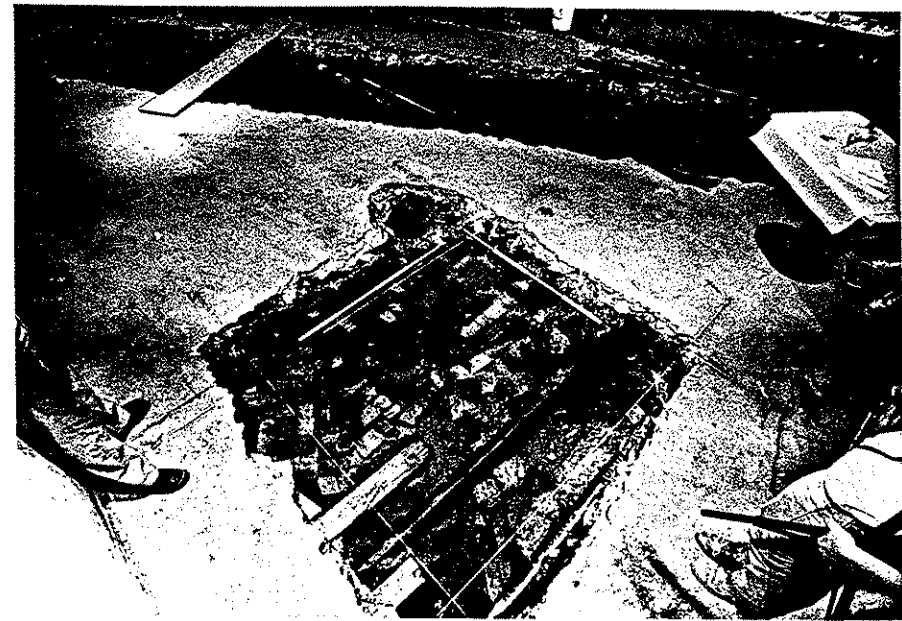
Plate 6.11. 12 North Warren Street, Excavation Unit B: view looking northwest during early stages of excavation; late 19th/early 20th century brick yard surface visible over most of unit; scale in feet (Photographer: Richard Hunter, August 1987).

Immediately the cement floor [1] had been removed it was clear from subsidence and the presence of underpinning for the floor [3, 8, 31] that deep-cut features would probably be found in this area. Beneath the early 20th-century cement floor was an earlier brick yard surface [2], laid in a simple pattern with blocks of masonry oriented both with and diagonal to the main axis of the property (Plates 6.11 and 6.12). This yard surface is probably equivalent to the fragmentary brick surface observed in Excavation Unit 1 [context 5] and is therefore likely to have originated in the mid-19th century. However, because of the date of underlying deposits in Excavation Unit B, portions of this surface appear to have been laid or relaid around the turn-of-the-century.

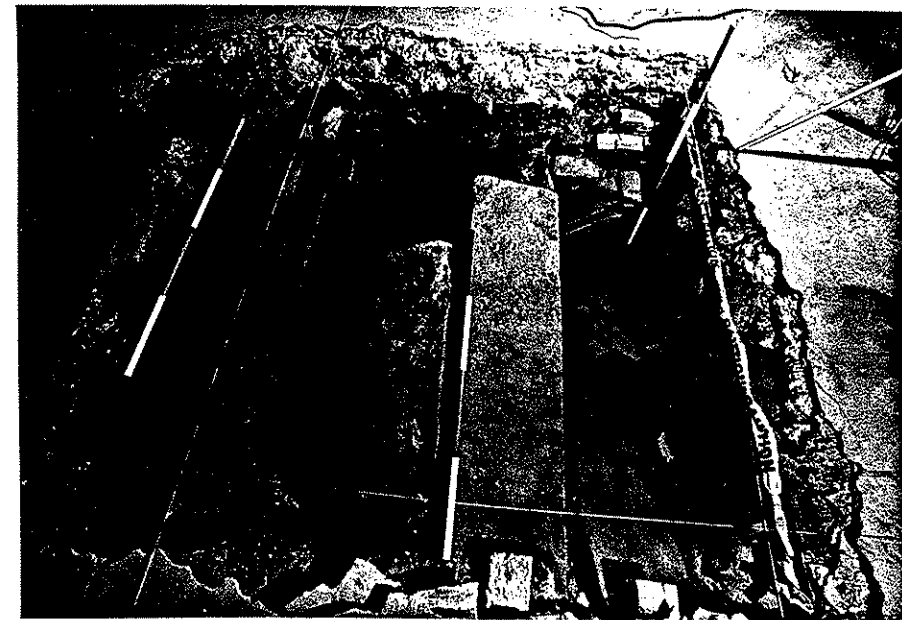
Plate 6.12. 12 North Warren Street, Excavation Unit B: view looking north showing large stone slabs covering mid- to late 19th century brick cistern; scale in feet (Photographer: Richard Hunter, August 1987).

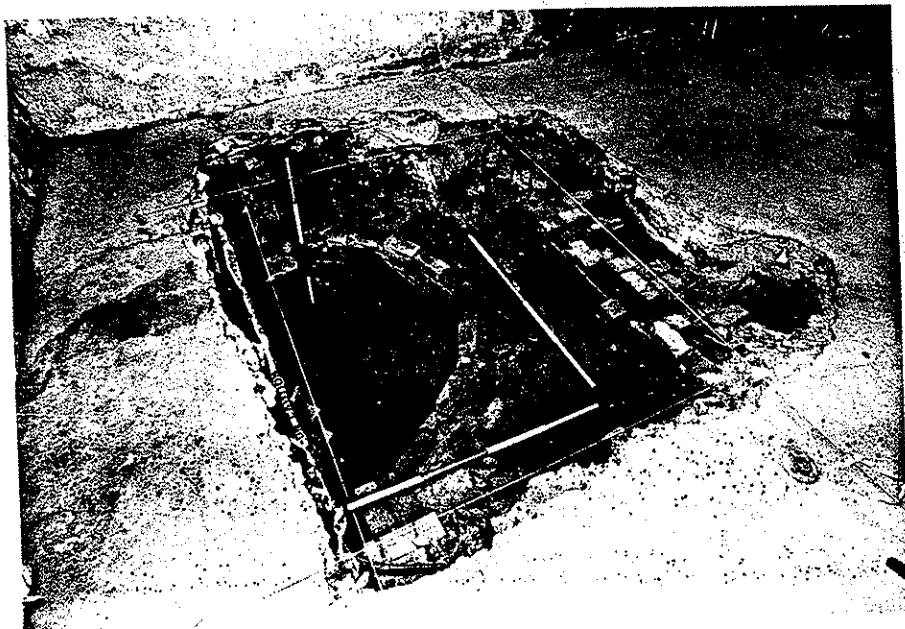
Plate 6.13. 12 North Warren Street, Excavation Unit B:  
view looking south southwest showing mid- to late 19th  
century brick cistern partially excavated; scale in feet  
(Photographer: Richard Hunter, August 1987).

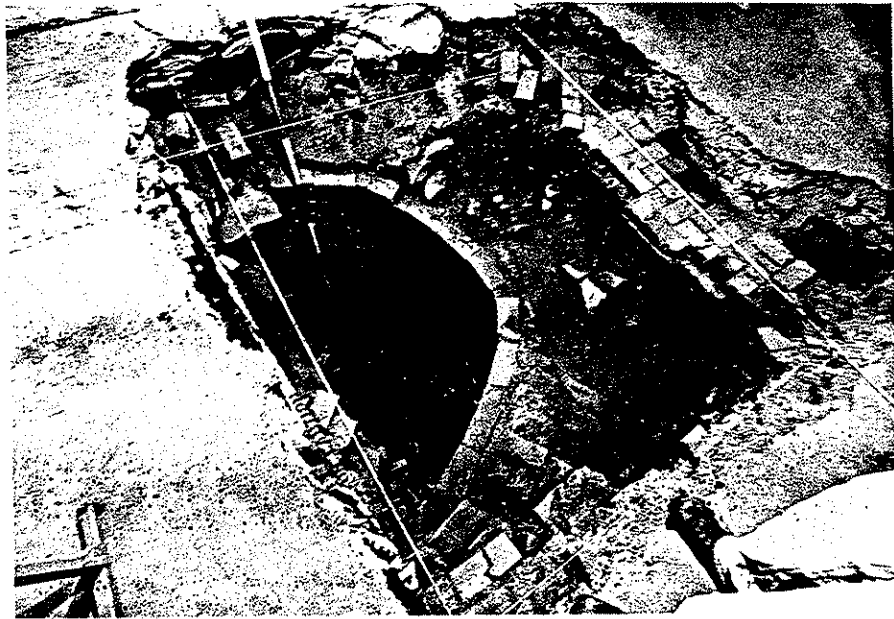
Plate 6.14. 12 North Warren Street, Excavation Unit B: view looking south southwest showing mid- to late 19th century brick cistern fully excavated; note large natural boulder at base of cistern; scale in feet (Photographer: Richard Hunter, August 1987).

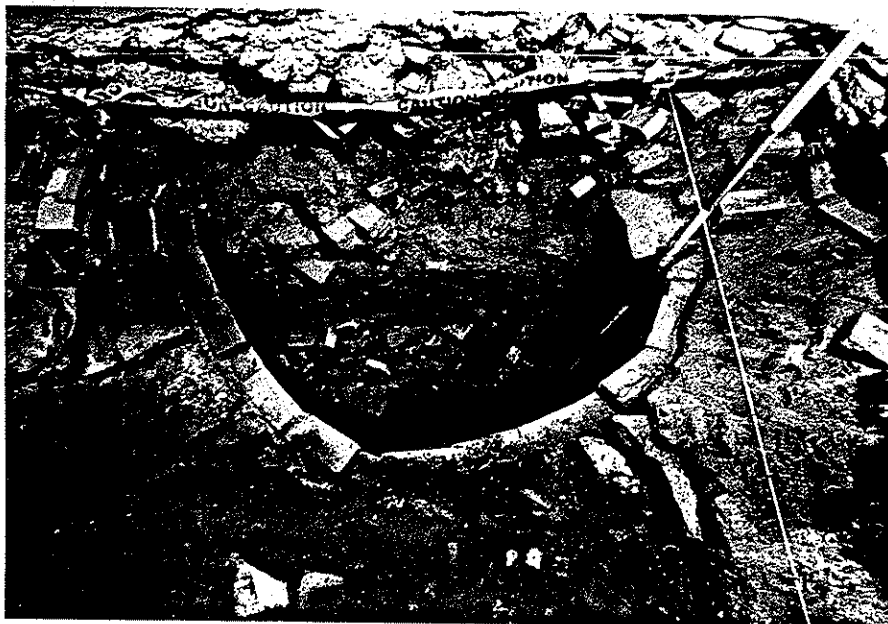
Plate 6.15. 12 North Warren Street, Excavation Unit B: view looking east showing fill of mid- to late 19th century brick cistern; scale in feet (Photographer: Richard Hunter, August 1987).

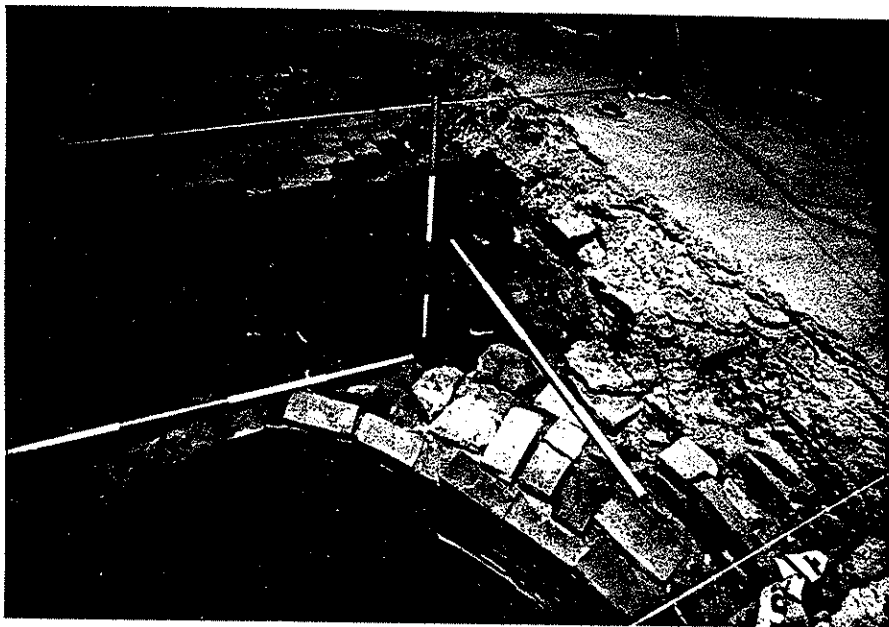
Plate 6.16. 12 North Warren Street, Excavation Unit B: view looking northwest showing mid- to late 19th century brick cistern in foreground; far end of horizontal scale pole at right rests on southwest corner of possible 18th century structure that was also observed in excavation unit A; scale in feet (Photographer: Richard Hunter, August 1987).

The cistern in Excavation Unit B, like the earlier cistern in Excavation Unit A, was also built up against the earlier stone foundation [28 and Excavation Unit A, context 30] discussed above. The southwestern corner of this square or rectangular structure was observed at the western end of the north profile of Excavation Unit B (Plate 6.16). Any evidence of a builders trench for this foundation had been removed through the construction of the cistern.

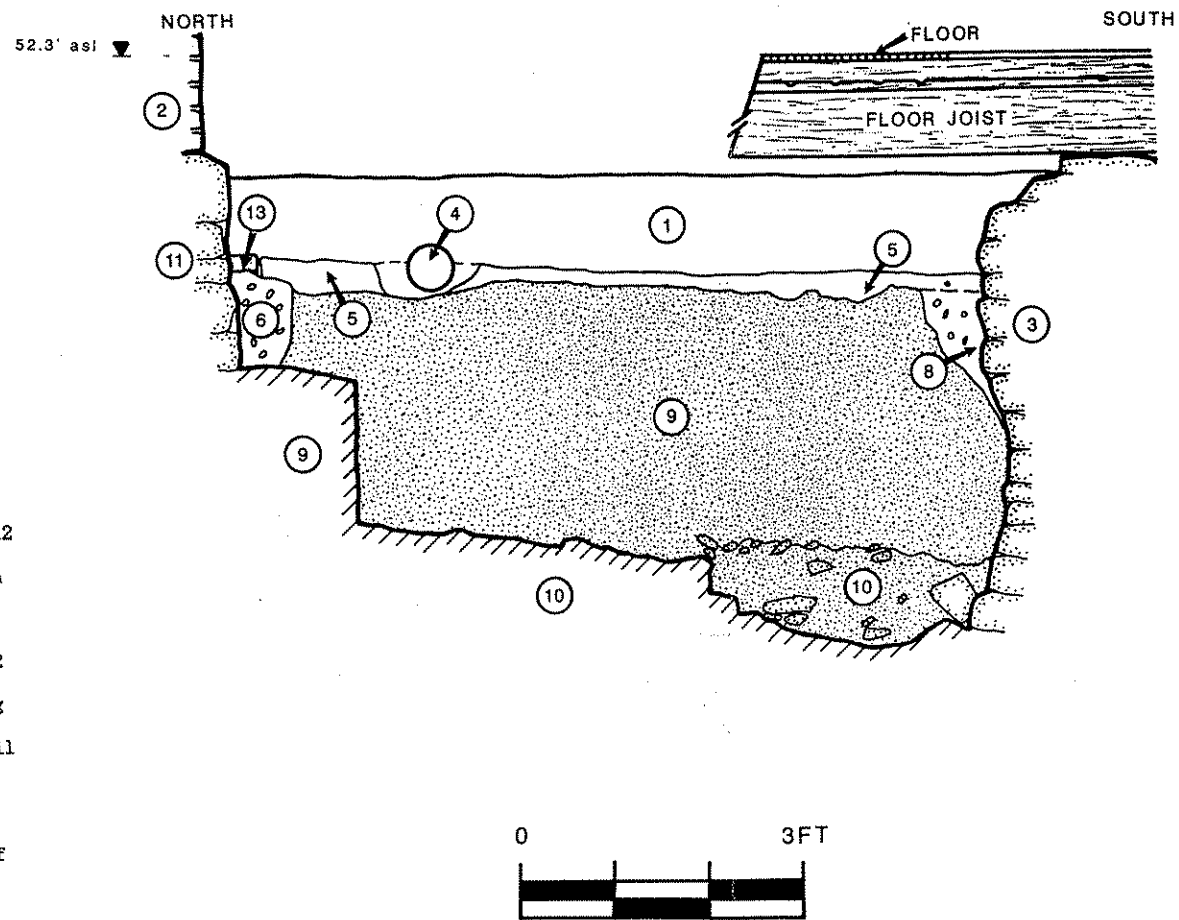
FIGURE 6.6. 12 NORTH WARREN STREET: EXCAVATION UNIT C

PLAN

- Context 1 - fill/debris [early 20thc]
- Context 2 - standing brick wall, north wall of 12 North Warren Street [early 20thc]
- Context 3 - north cellar wall of 12 North Warren Street [early 1820s]
- Context 4 - water line [early 20thc]
- Context 5 - construction deposit [early 20thc]
- Context 6 - builders trench for north wall of 12 North Warren Street [?early 1820s]
- Context 7 - possible post hole, ?for scaffolding [?early 1820s]
- Context 8 - builders trench for north cellar wall of 12 North Warren Street [early 1820s]
- Context 9 - base of yard build-up/garden soil and subsoil [mid-18th thru early 19thc]
- Context 10 - subsoil
- Context 11 - stone foundation for north wall of 12 North Warren Street [?early 1820s]
- Context 12 - pipe trench [early 20thc]
- Context 13 - brick surface [?19thc]

EAST PROFILE

Excavation Unit C (Matrix 6.3; Figure 6.6; Plates 6.17 and 6.18; Appendices B.ii and C.ii) measured 3.5 by 9 feet and was located on the north side of the center section of 12 North Warren Street (Figure 6.1). The unit was oriented north-south, perpendicular to the main axis of 12 North Warren Street and the alley to the north.

The foundations and their builders trenches observed at the north and south ends of the unit were the only major features of any antiquity. The northern brick wall of the early 20th-century structure [2] was laid on top of a stone foundation [11] that was probably the base of an earlier property wall. The builders trench [6] for this latter foundation contained early 19th-century artifacts, so this wall probably represented the property boundary established in the first quarter of the 19th century between 12 North Warren Street and the alley to the north. A line of bricks [13] adjacent to this foundation may have been a yard surface remnant or underpinning for a yard. At the opposite end of the unit, the outside face of the north wall of the rear basement section of 12 North Warren Street was revealed [3] (Figure 6.2). The builders trench [8] for this wall also produced early 19th-century artifacts, confirming that this portion of the building dated originally from the early 1820s. A single posthole [7] may have been related to the construction of this rear portion of the Stephen Rose house.

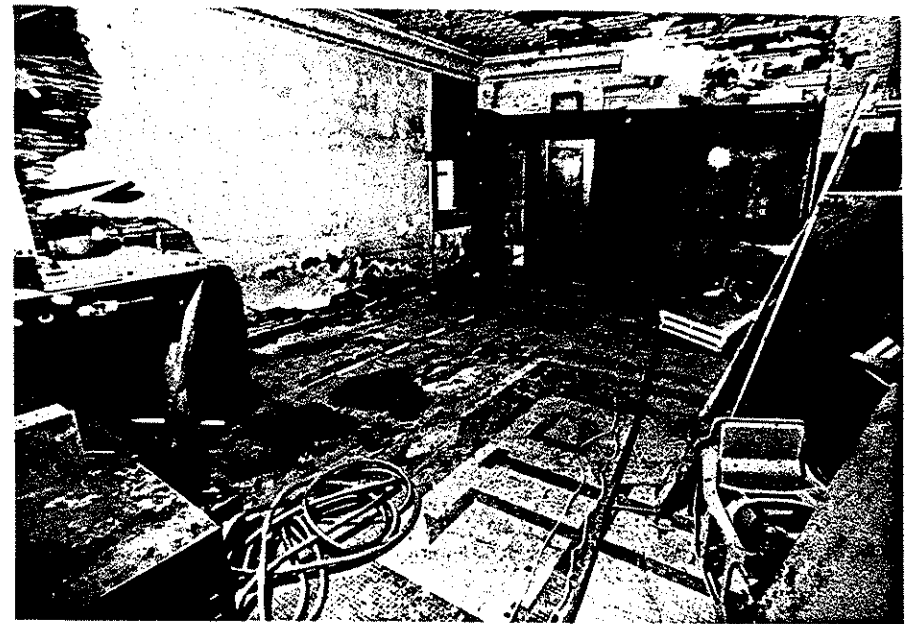
Plate 6.17. 12 North Warren Street, Excavation Unit C: general view looking northeast prior to beginning excavation; horizontal scale pole marks location of unit; scale in feet (Photographer: Richard Hunter, August 1987).

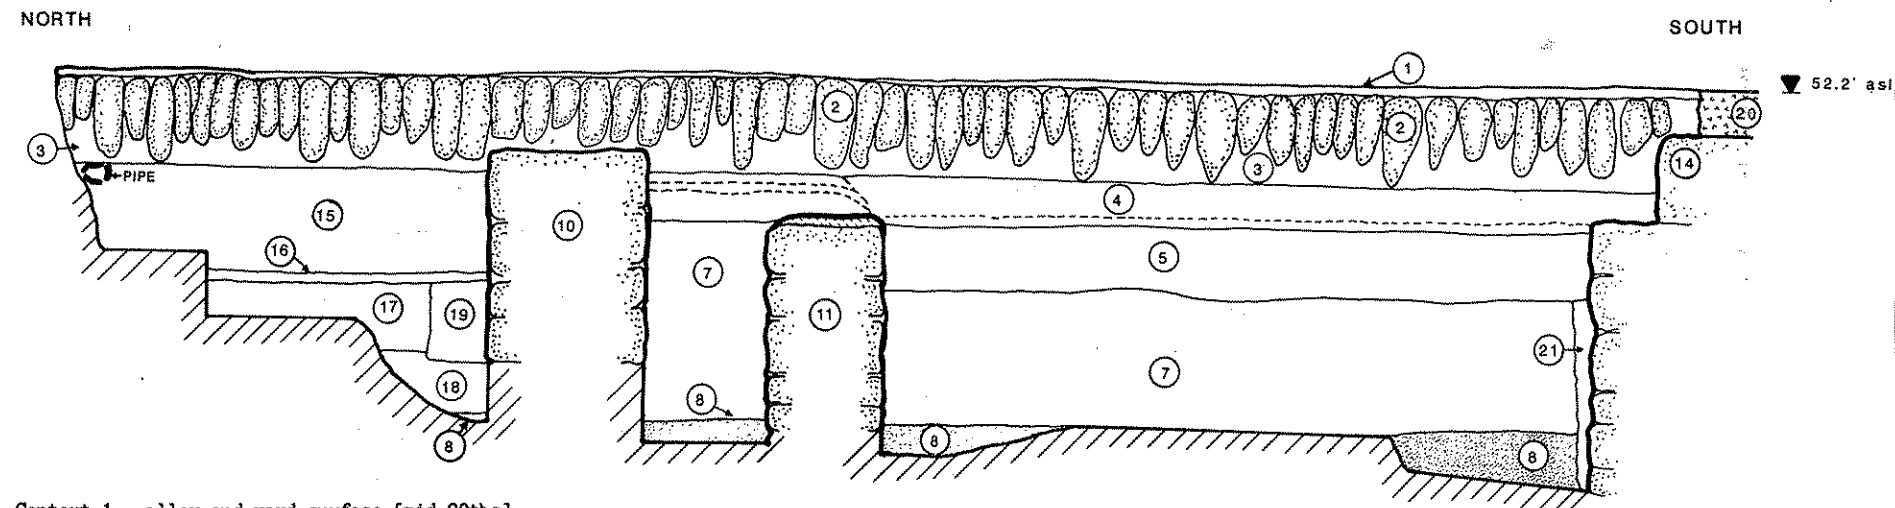
FIGURE 6.8. 14 NORTH WARREN STREET: ALLEY EXCAVATION UNIT

EAST PROFILE

- Context 1 - alley and yard surface [mid-20thc]
- Context 2 - alley and yard surface [early 20thc]
- Context 3 - fill and leveling deposit for cobble surface [early 20thc]

- Context 4 - fill [?19thc]
- Context 5 - yard build-up/garden soil [19thc]
- Context 7 - yard build-up/garden soil [late 18th thru mid-19thc]
- Context 8 - subsoil

- Context 10 - stone wall, ?outbuilding foundation [?early 19thc]
- Context 11 - stone wall, ?outbuilding foundation or garden boundary [?late 18thc]
- Context 14 - stone wall, ?property boundary or outbuilding foundation [?early 19thc]

- Context 15 - fill [19thc]
- Context 16 - fill [19thc]
- Context 17 - yard build-up/garden soil or ?fill [late 18thc/early 19thc]
- Context 18 - yard build-up/garden soil or ?fill

- Context 19 - builders trench for wall [10] [19thc]
- Context 20 - pavement at rear of alley [20thc]
- Context 21 - builders trench for wall [14] [?early 19thc]

The Alley Excavation Unit (Matrix 6.4; Figure 6.7 and 6.8; Plates 6.19-6.21; Appendices B.ii and C.ii) originated as a 16-foot long, 1.5-foot wide trench excavated in the Phase 1 investigations. This was then expanded westwards in the Phase 2 studies to encompass an area of approximately 70 square feet. This unit was mostly located in what was historically the rear portion of 14 North Warren Street, although its southern tip extended into the eastern end of the alley between 12 and 14 North Warren Street. The eastern end of the alley, in its final 20th-century manifestation, included part of the rear section of 14 North Warren Street (Figures 4.21-4.23 and 6.7).

Two parallel east-west foundations [10, 14], from the associated stratigraphic and artifactual evidence, appear to have dated from the early to mid-19th century. These foundations correspond with structures shown in the rear part of 14 North Warren Street on historic maps of the last quarter of the 19th century (Figures 4.16-4.18). These structures were torn down sometime between 1891 and 1905 during the True American era, when the rear portion of 14 North Warren Street was remodeled so that a part of the building remained open at the first story. This was basically how the building appeared in 1987 (Figures 4.19-4.23). These changes to the rear of the building around the turn of the century were presumably to facilitate loading and unloading of materials used in the True American printing operation.

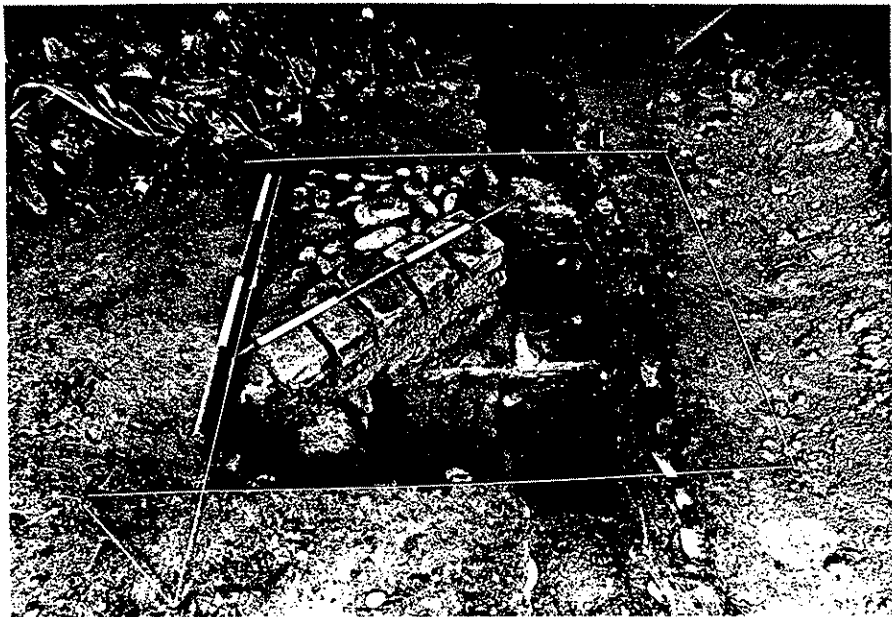
Plate 6.19. 14 North Warren Street, Alley Excavation Unit: general view looking north during early stages of excavation showing early 20th century cobble and Belgian block yard surface overlying earlier walls; scale in feet (Photographer: Richard Hunter, May 1987).

Beneath the 20th-century asphalt and cobble alley surfaces [1, 2], a complex series of walls and other buried remains was encountered, ranging in date from the 18th through the 20th centuries (Plates 6.19-6.21). Unfortunately, intensive use of this area and the destructive effects of each successive building phase on pre-existing structures made full interpretation of the archaeological remains in this unit very difficult.
